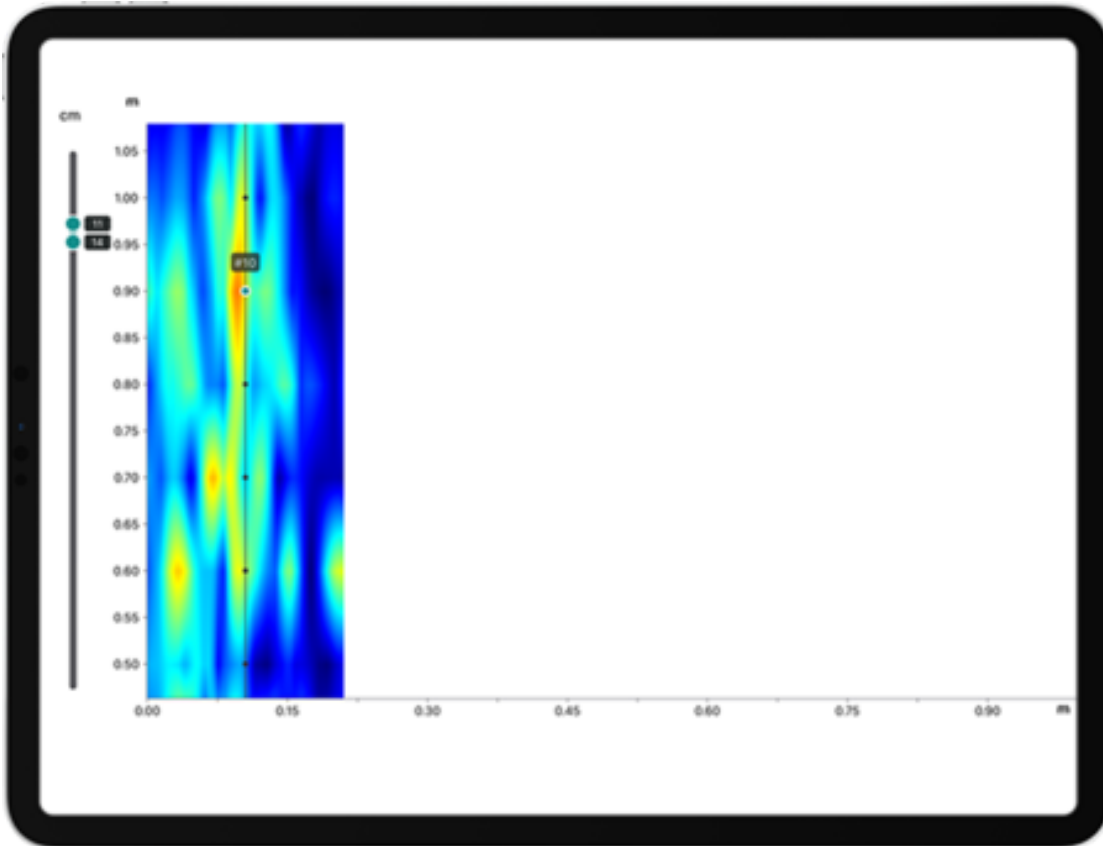
Void detected inside mortar joint slightly to left. The black centre line above indicates the location of the joint. The joint was broken out (below) to check for voiding.

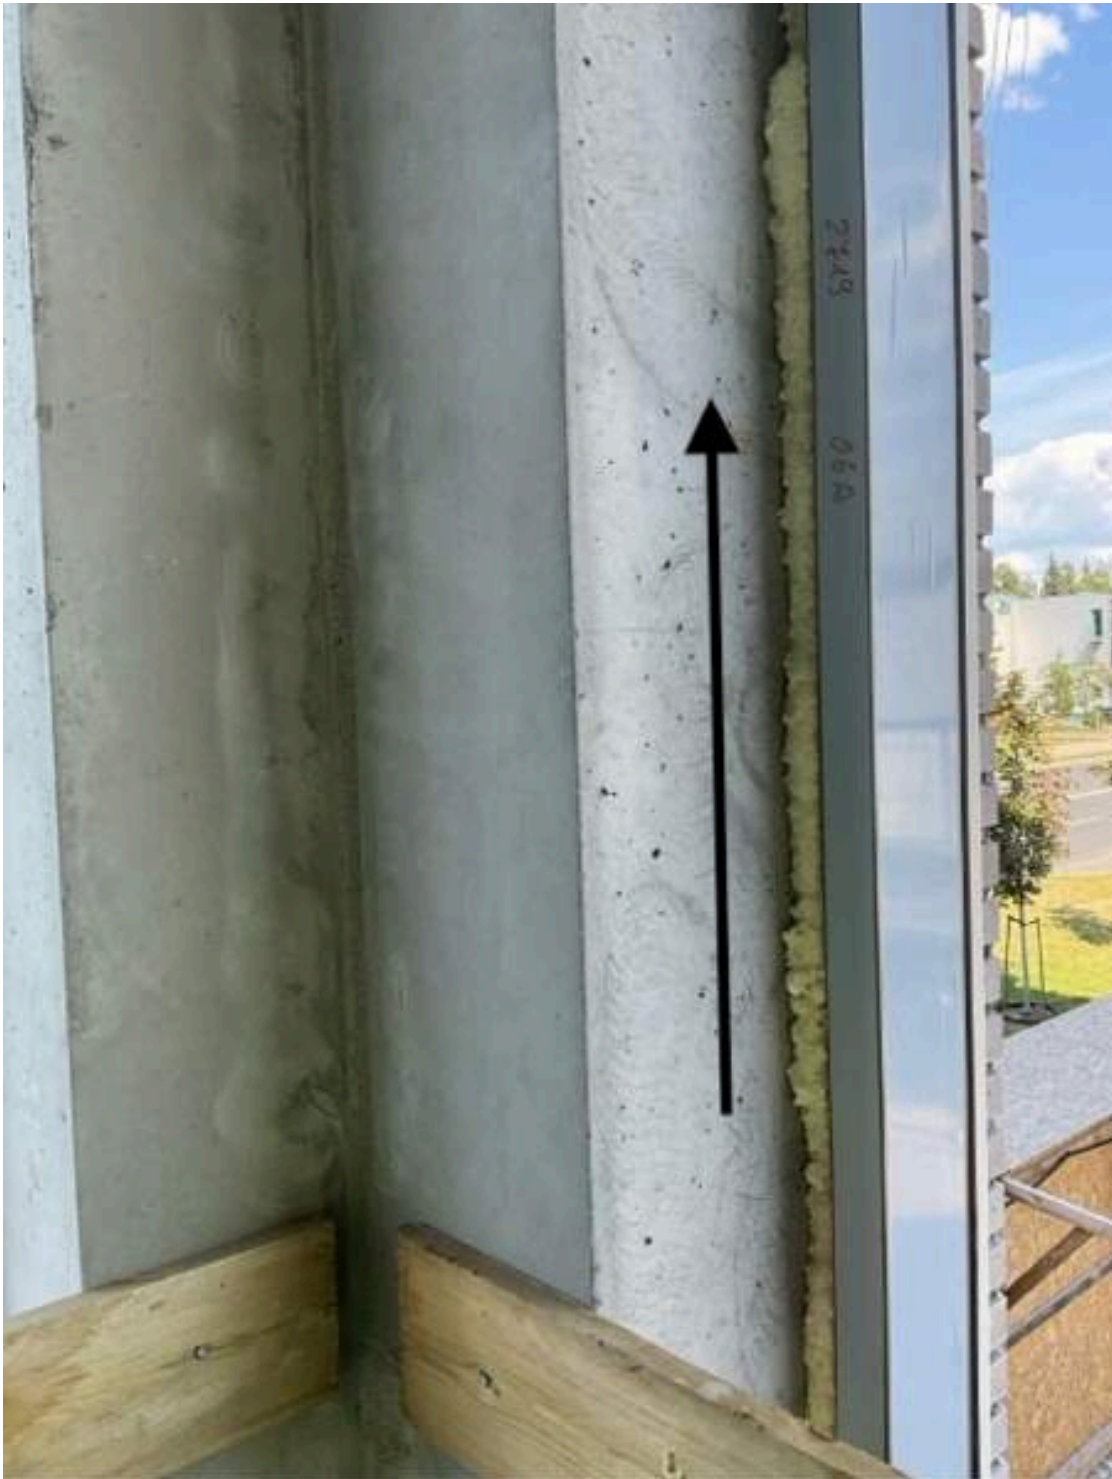
The black arrow shows the direction of the scan along the window reveal.
