# Detecting possible voids behind PT cable anchors

This application note describes how to inspect a new multistorey concrete building with post-tensioned floor slabs.

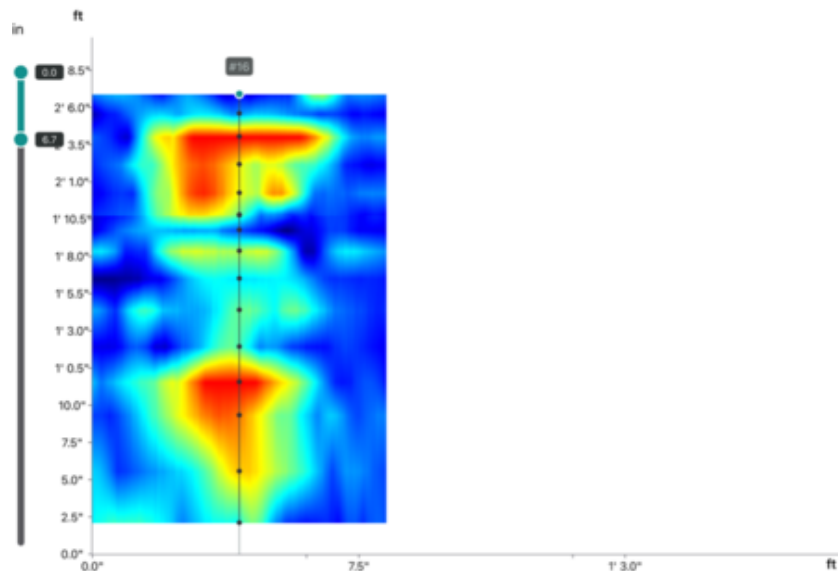
The contractor experienced several instances of the PT cable anchor being pulled into the concrete when the tensioning force was applied. It was suspected that the congested rebar configuration led to voids in the concrete behind the anchors.

Figure 1 – Stripe scan of problem area showing strong reflection from discontinuity in the concrete around the PT cable.

Repair is an expensive proposition that requires chipping of the concrete and delays on the construction schedule. There are also significant safety issues with the repair process since the anchors are on the edge of the floor several stories up in the air.

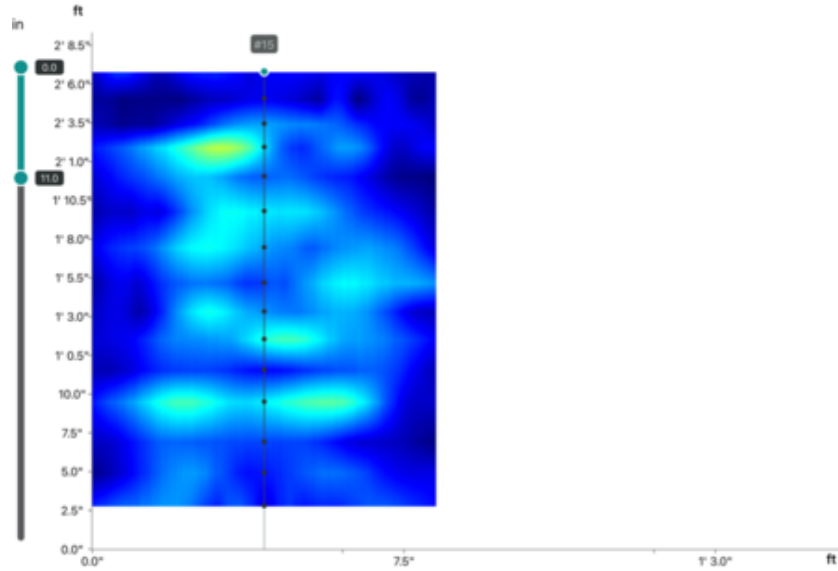
Figure 2 – Stripe scan of good area with lack of strong reflections indicating solid concrete around the PT
