Revealing hidden voids and unexpected findings on the post-tensioning ducts of concrete bridges

Screening Eagle uncovers surprising results with non-destructive testing on Huntingdon Railway Viaduct in the UK with National Highways

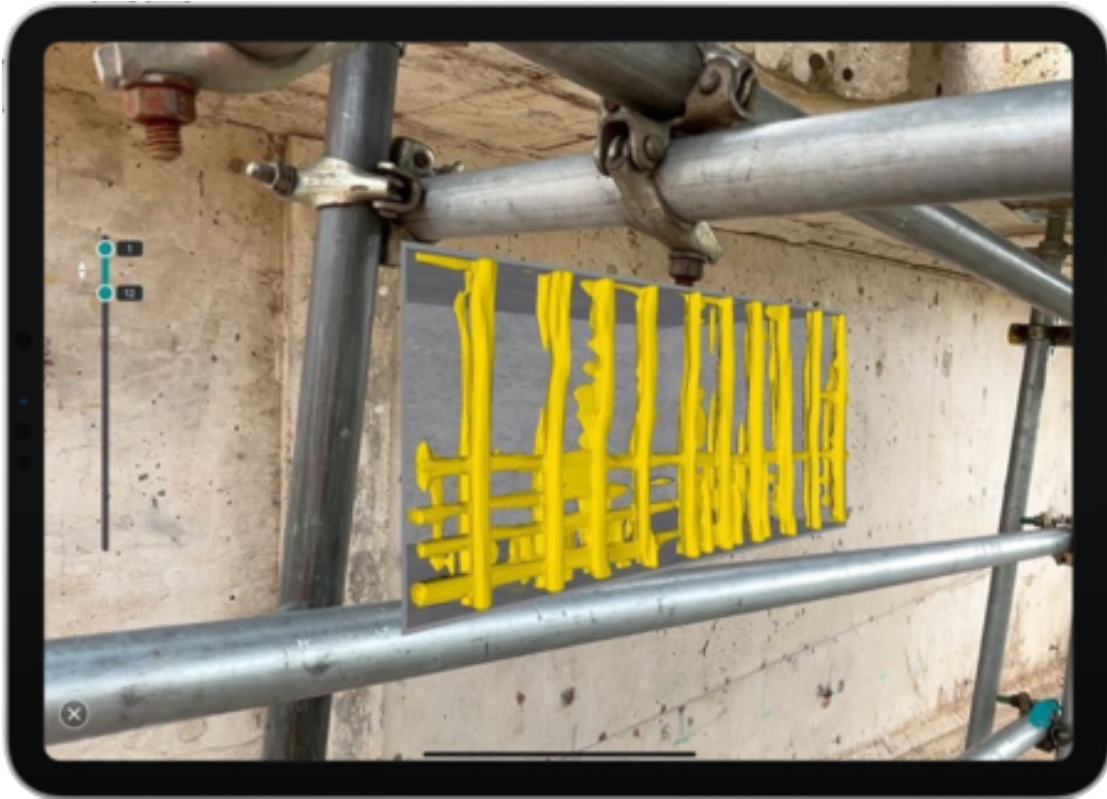
Augmented reality view of the GPR data results showing the rebar configuration with missing horizontal rebar at the top.

Oddly, the GPR data shows that there are no horizontal steel reinforcement over the top of the duct location. This is unlikely to be a design feature and is most likely a construction fault.
