Detecting possible voids behind PT cable anchors

This application note describes how to inspect a new multistorey concrete building with post-tensioned floor slabs.

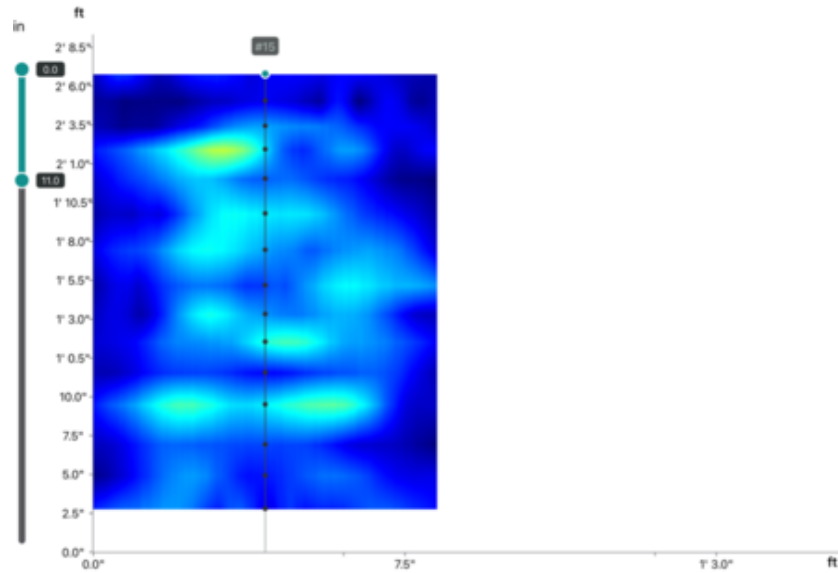
Figure 2 – Stripe scan of good area with lack of strong reflections indicating solid concrete around the PT
