Inspecting dock road slab structures with ground penetrating radar

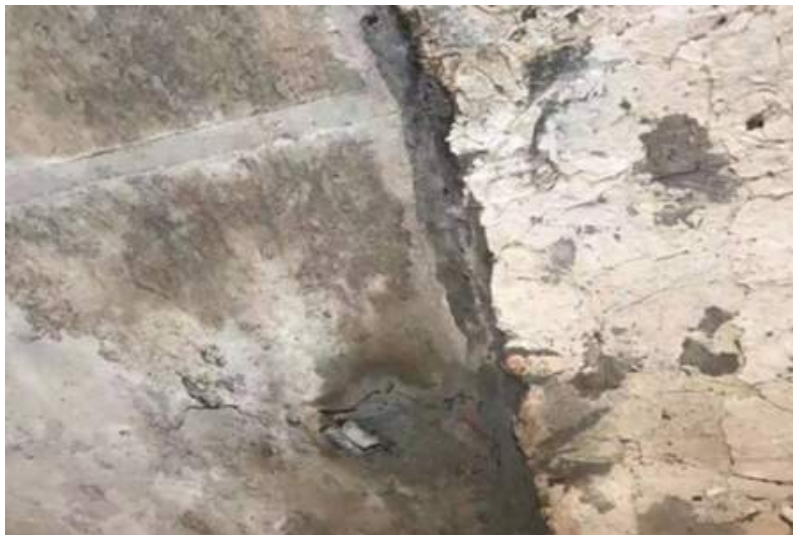
Undamaged areas (back plate)
