# Inspecting dock road slab structures with ground penetrating radar

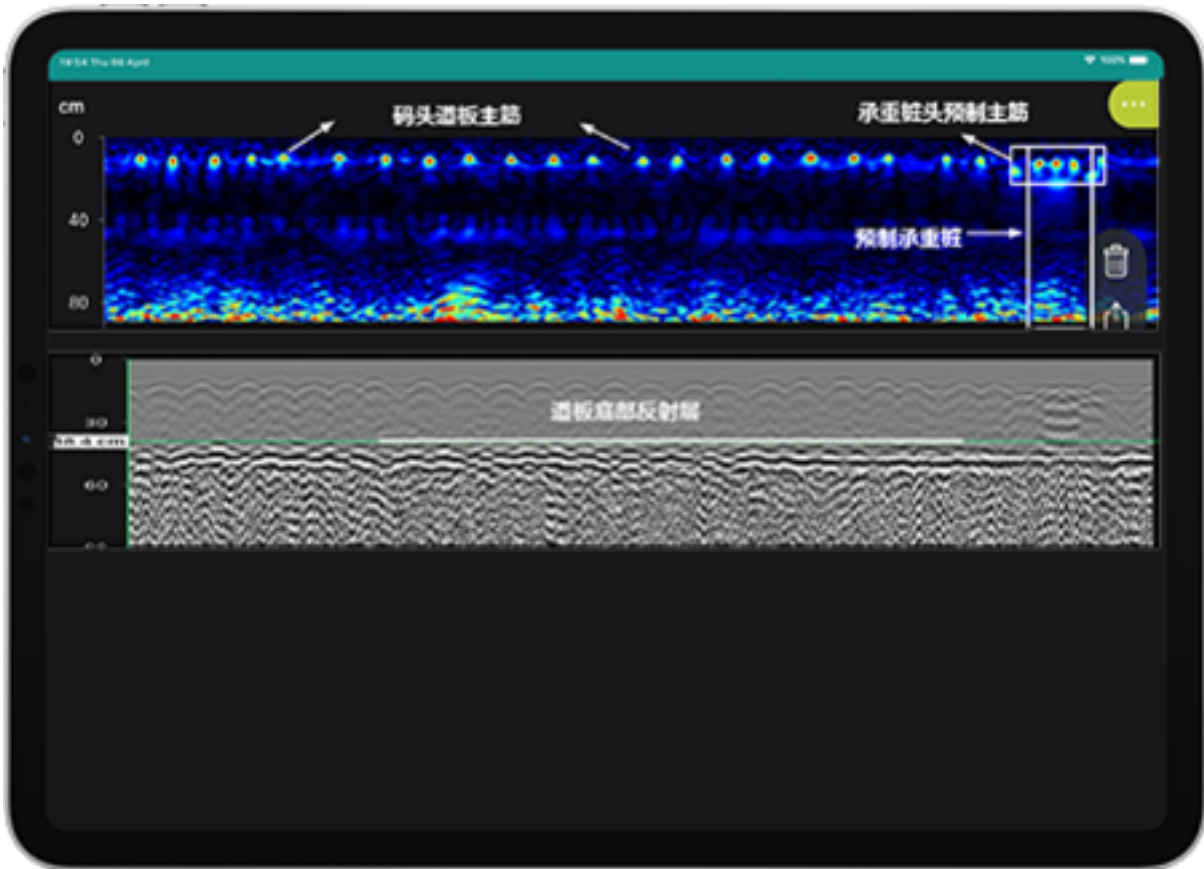
The radar map of the Road Plate detected by GP8000

As can be seen from the figure, the GP8000 can clearly detect the health of the debut plate structure: the main rib is clearly visible, the bottom reflection is clear and continuous, flat, and there is no large-scale spalling and damage at the bottom.

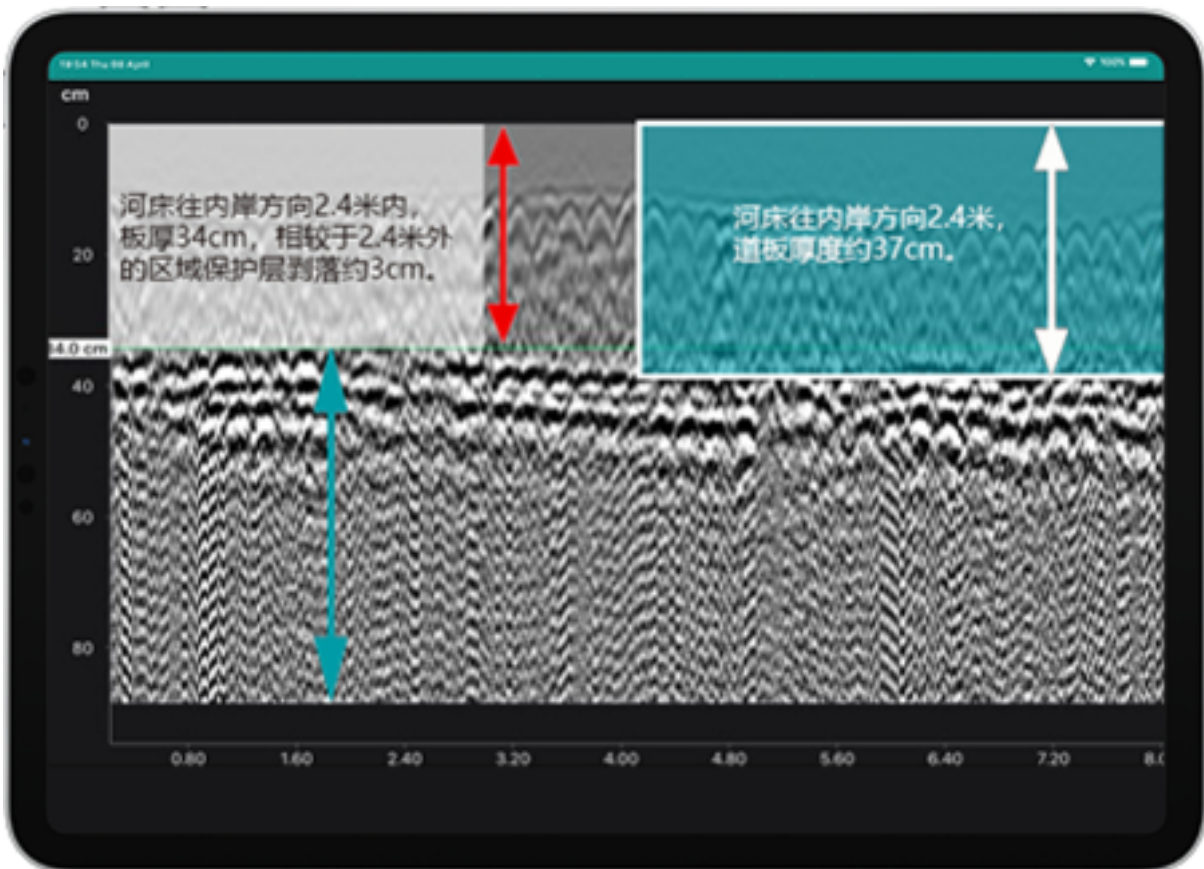
Suspected damage to the road plate detected by GP8000

Through the GP8000 radar checking test, it is not difficult to find that the thickness of front plate where riverbed is within 2.4 meters to the inner bank is about 34cm; and the thickness of back plate where the riverbed is 2.4 meters away from the inner bank is about 37cm. that means the protective layer of the front plate is reduced by about 3 cm.
