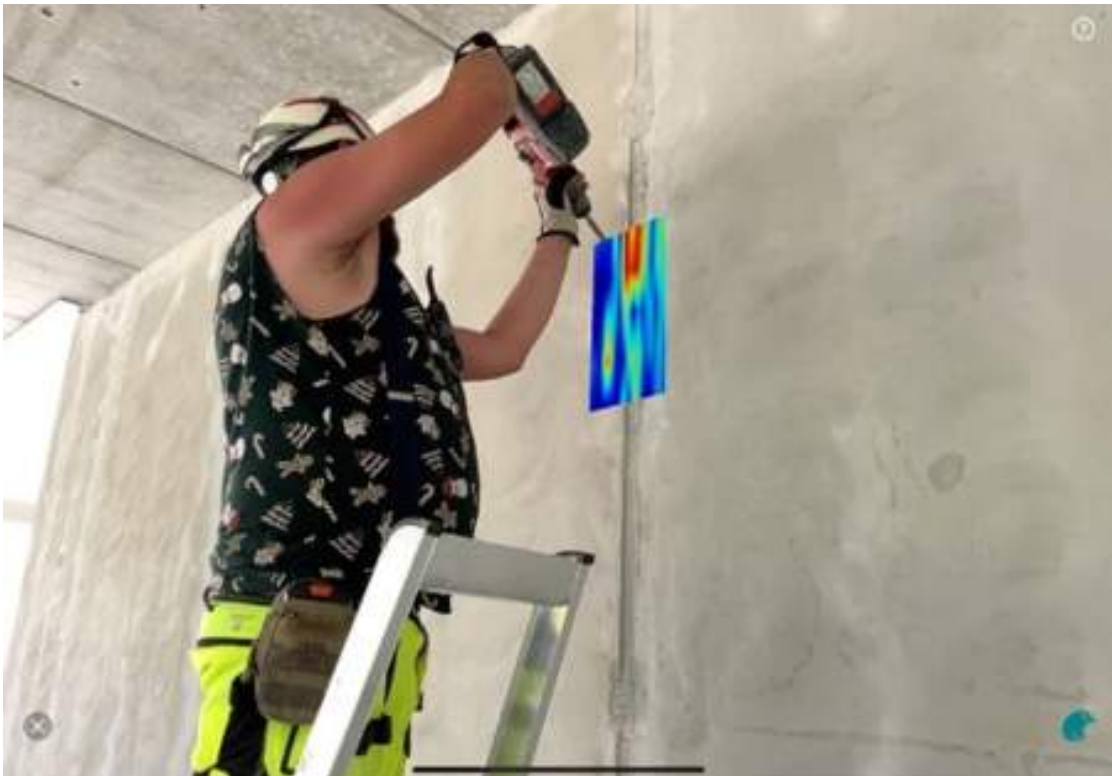
Breakout of potential void done by site engineer on the second scanning site with AR overlay of estimated voided area. Red area of scan indicates voiding in the joint.
