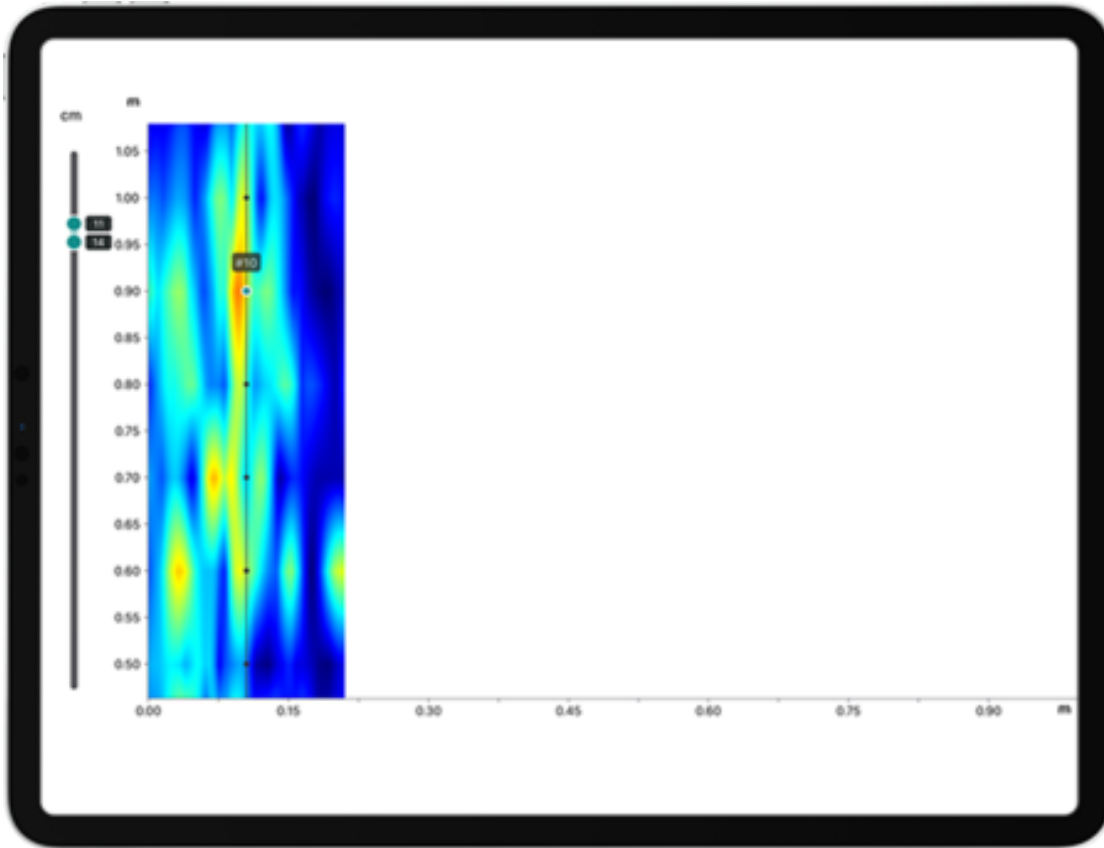
Void detected inside mortar joint slightly to left. The black centre line above indicates the location of the joint. The joint was broken out (below) to check for voiding.

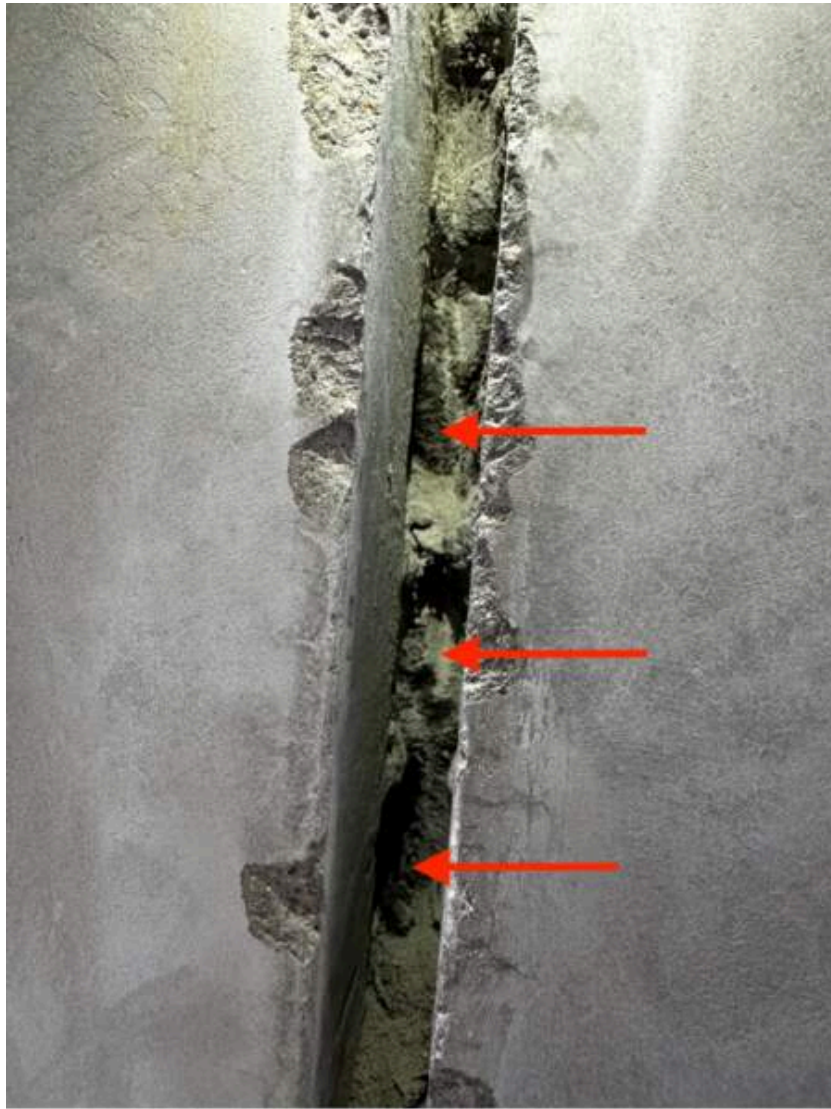
First scan location was voided in joint where red arrows are

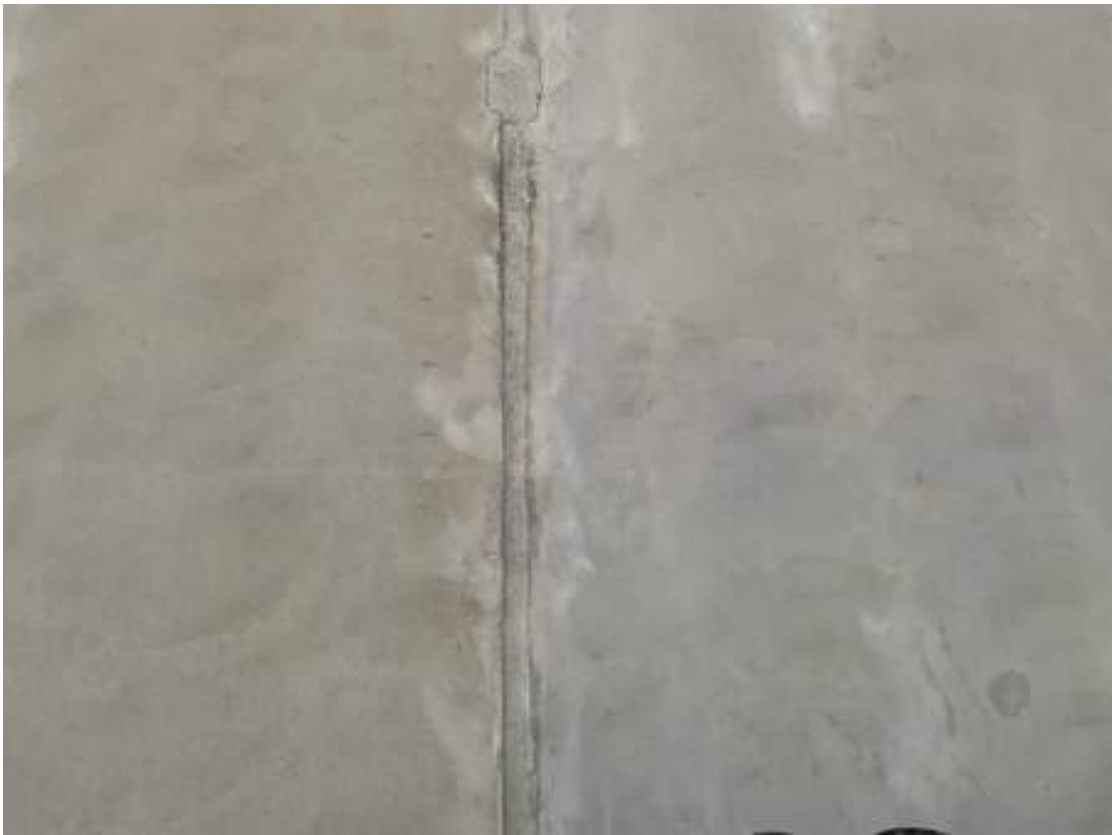
Second scan location was voided at the top of the scan

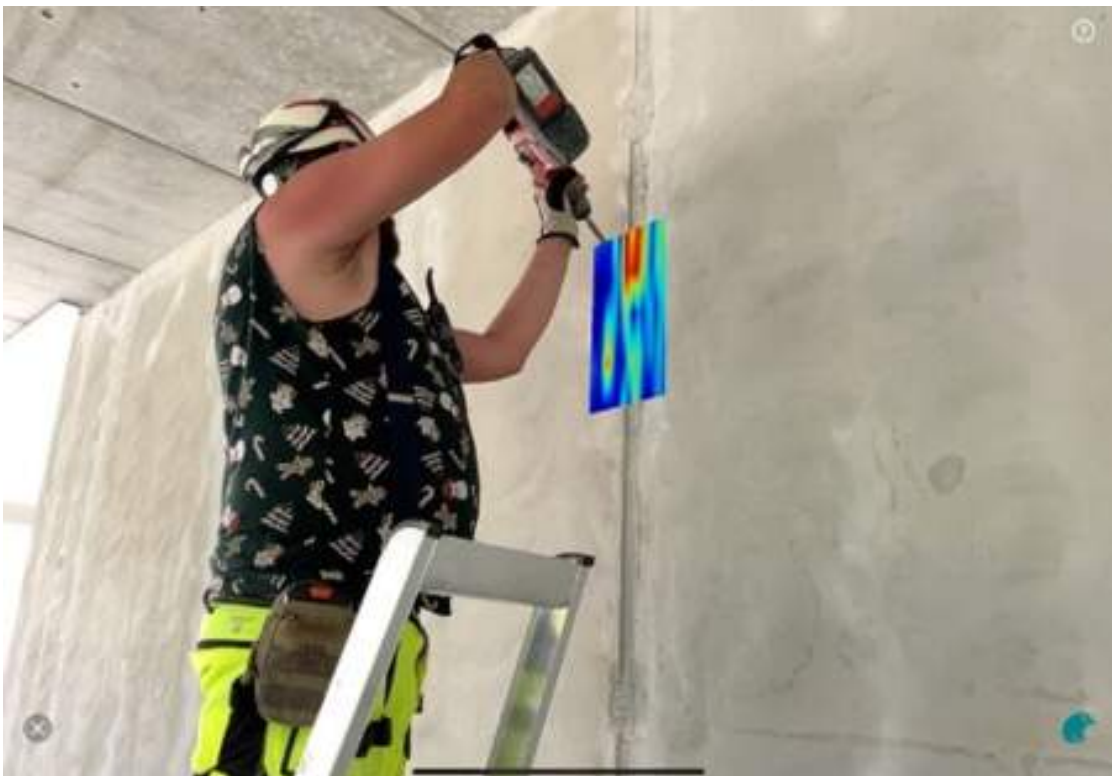
Breakout of potential void done by site engineer on the second scanning site with AR overlay of estimated voided area. Red area of scan indicates voiding in the joint.

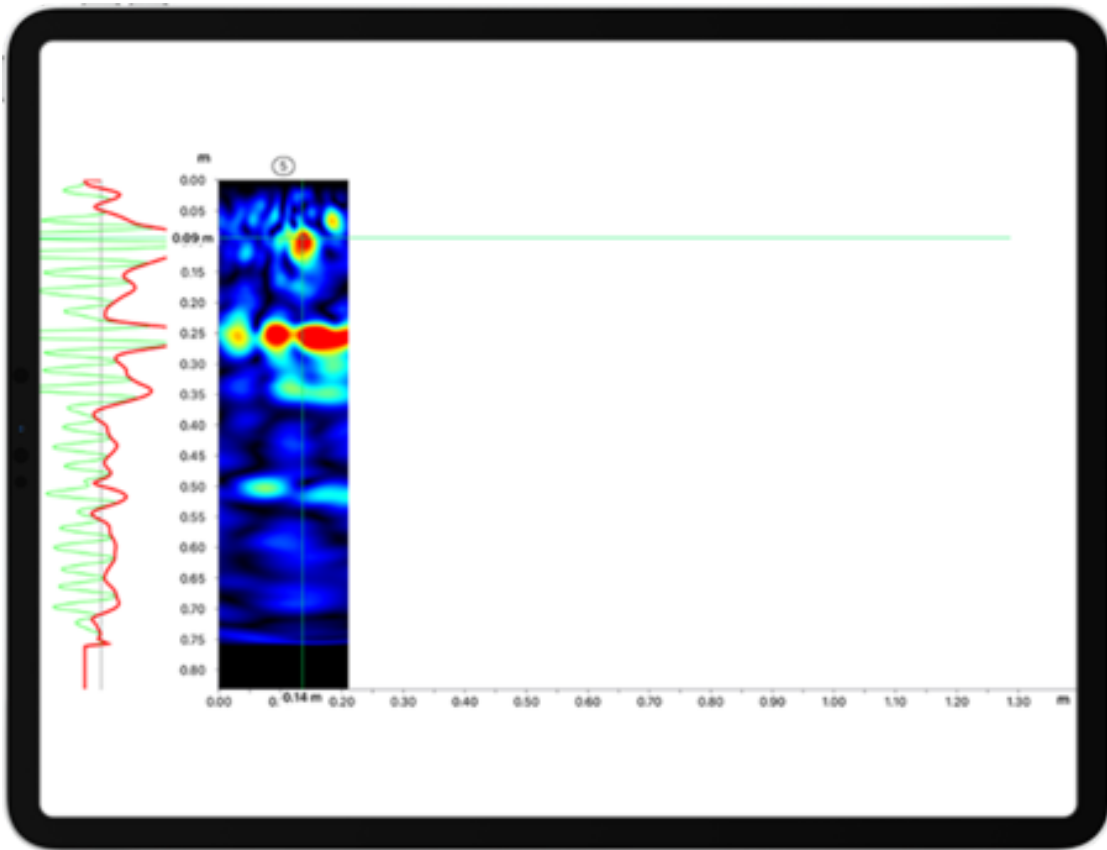
Voided where green crosshairs are.

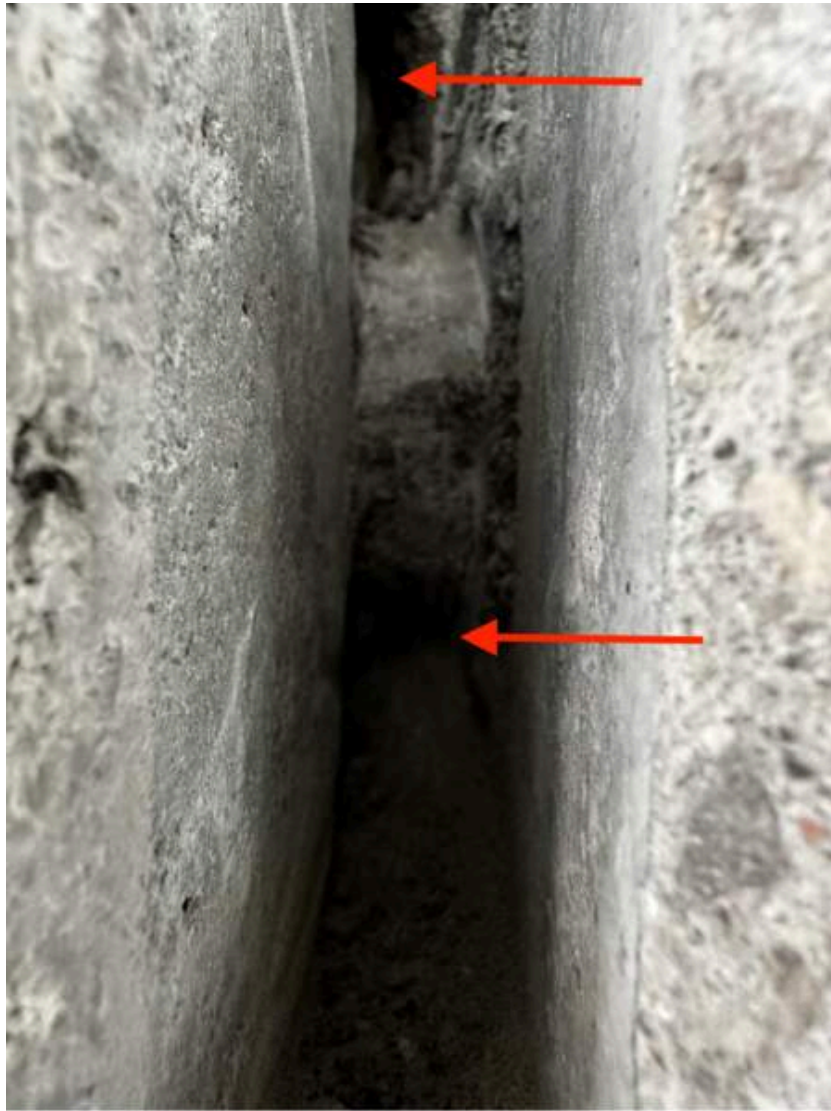
located voids in the joint

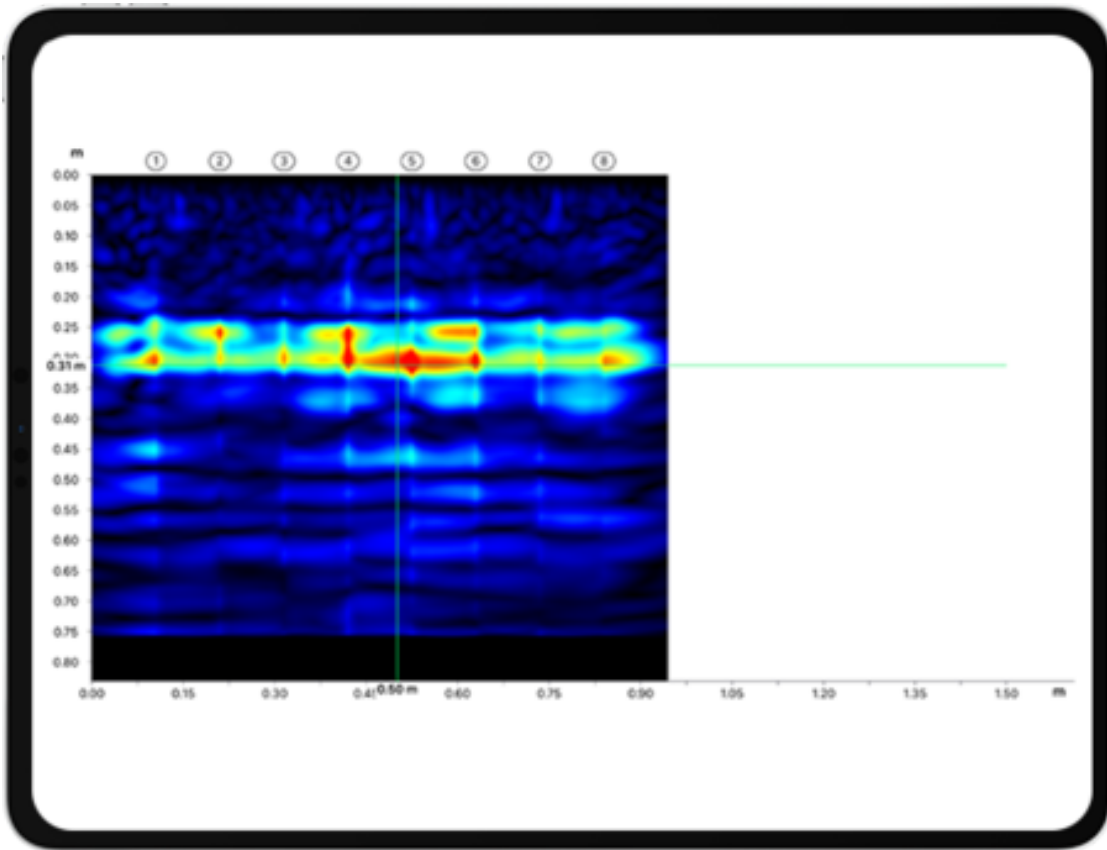
Line scan data from the corner scan. The data points to a possible void or poor bond at the crosshairs location.
