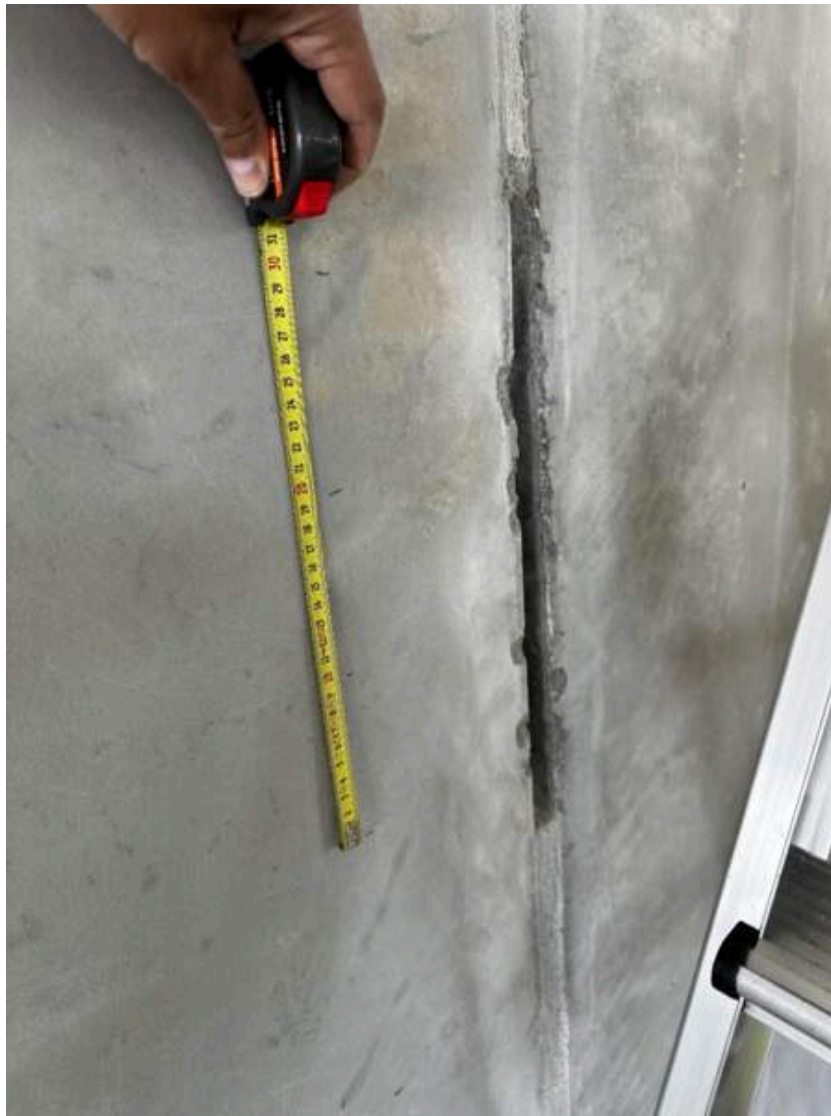
Voiding found over a 30cm length (they didn't break out the entire length of the void. Total length of voided joint section was estimated at 45cm)

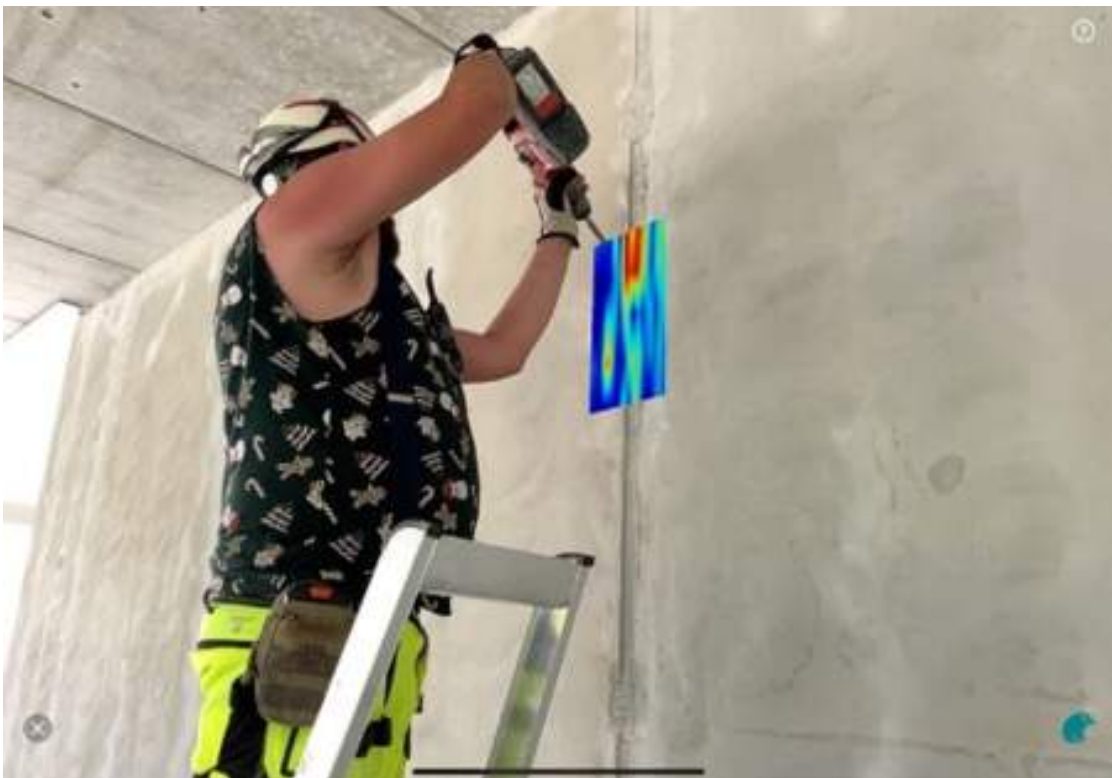
Breakout of potential void done by site engineer on the second scanning site with AR overlay of estimated voided area. Red area of scan indicates voiding in the joint.
