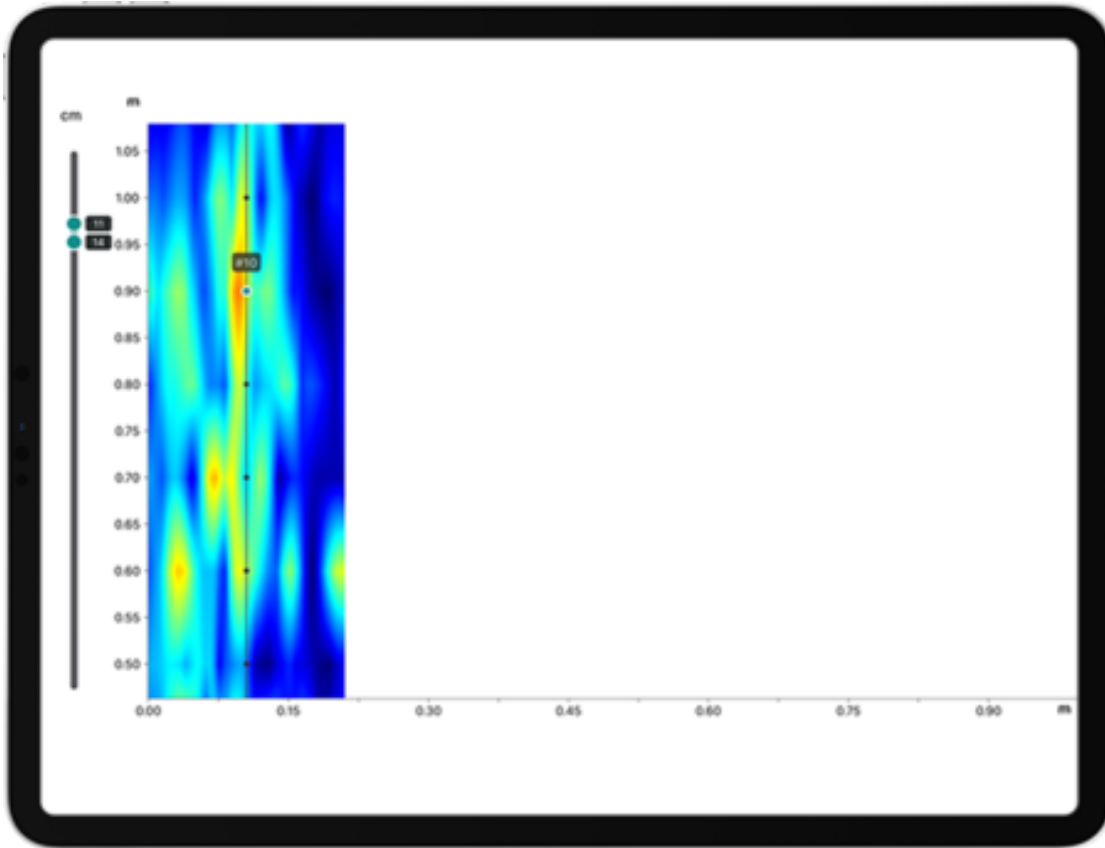
Void detected inside mortar joint slightly to left. The black centre line above indicates the location of the joint. The joint was broken out (below) to check for voiding.
