Detecting possible voids behind PT cable anchors

This application note describes how to inspect a new multistorey concrete building with post-tensioned floor slabs.

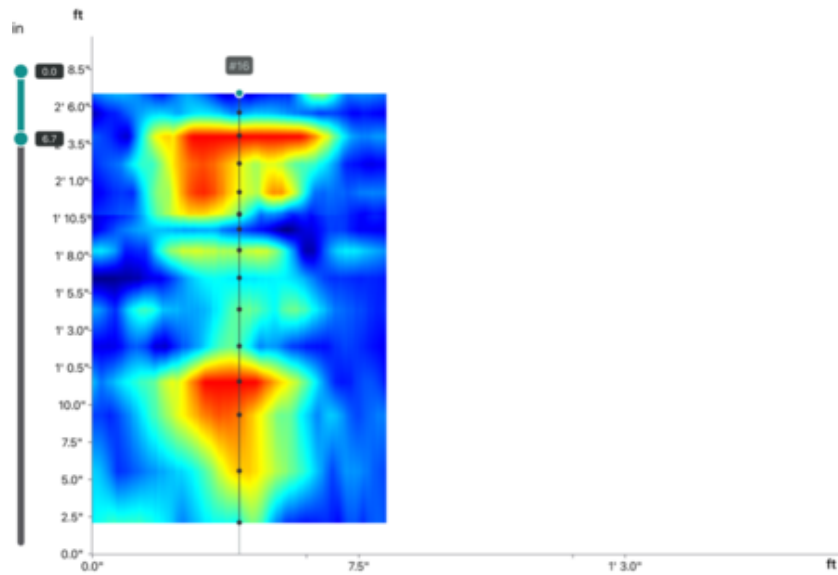
The contractor experienced several instances of the PT cable anchor being pulled into the concrete when the tensioning force was applied. It was suspected that the congested rebar configuration led to voids in the concrete behind the anchors.

Figure 1 – Stripe scan of problem area showing strong reflection from discontinuity in the concrete around the PT cable.

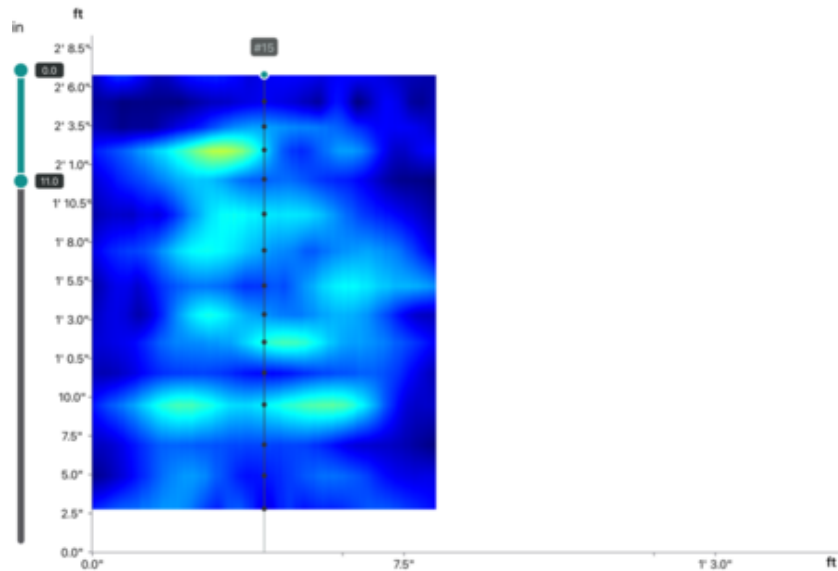
Figure 2 – Stripe scan of good area with lack of strong reflections indicating solid concrete around the PT
