如何使用 GPR 和超声波检查新建隧道的渗水点？

测试结果 - B 区

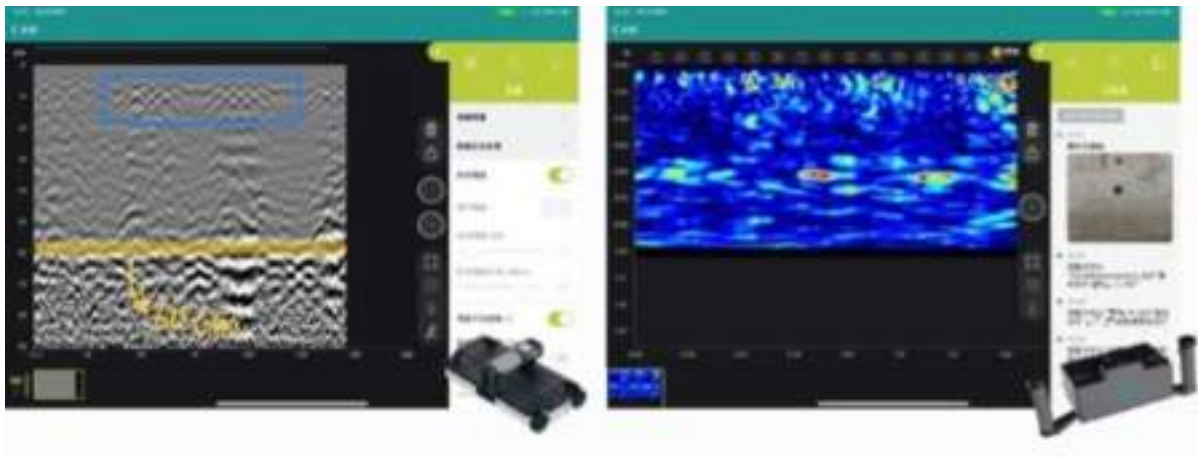
PD8050 Linear Scan Results

通过对 GP8100 线性视图（左图）和 PD8050 线性视图（右图）的分析，我们可以看到在 60 cm 的深度处有浅层钢筋信号和初支底板的连续信号，钢筋和底板之间没有明显的富水区。综上所述，可以初步判断 A 区施工质量良好，无明显渗水现象。

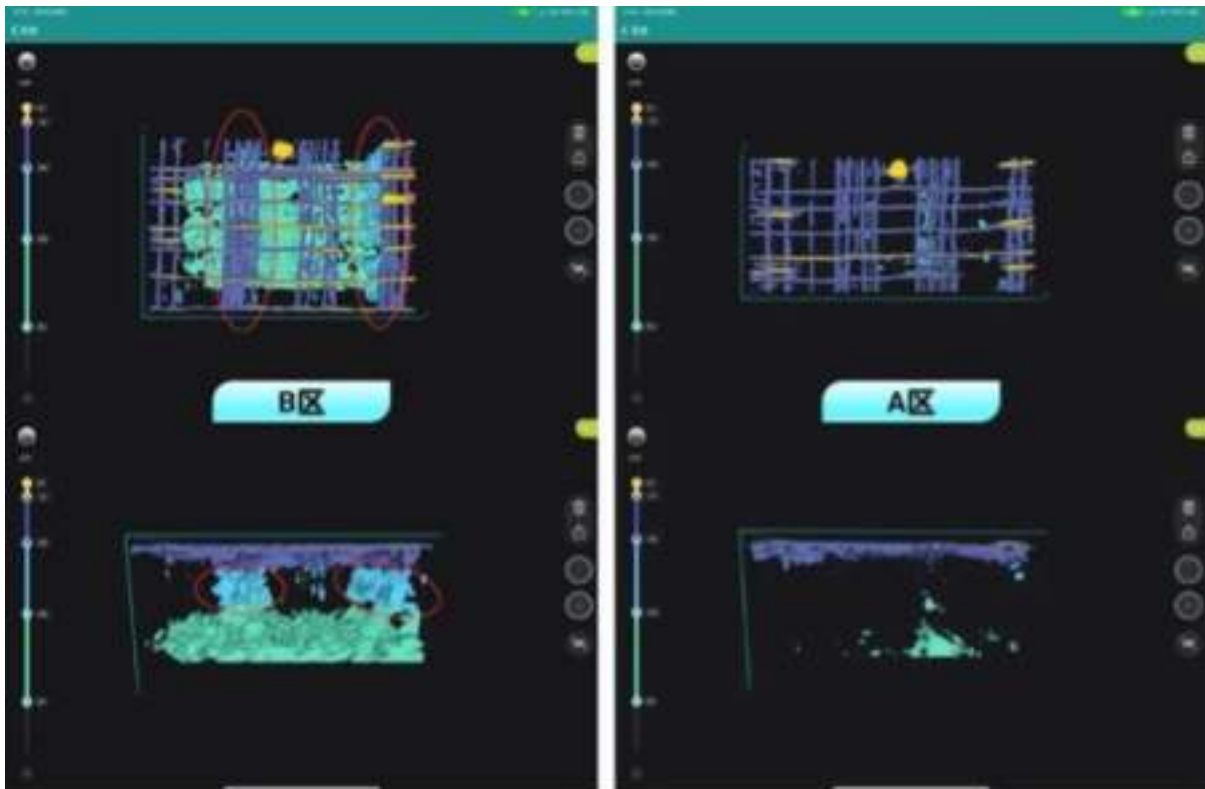
Comparison of Radar Line Scanning in Zone A and Zone B

左图为 B 区 8 号线剖面图，右图为 A 区 9 号线剖面图。从两张图的对比来看，A 区没有富水或渗水现象，B 区钢筋与楼板之间有明显的富水信号。

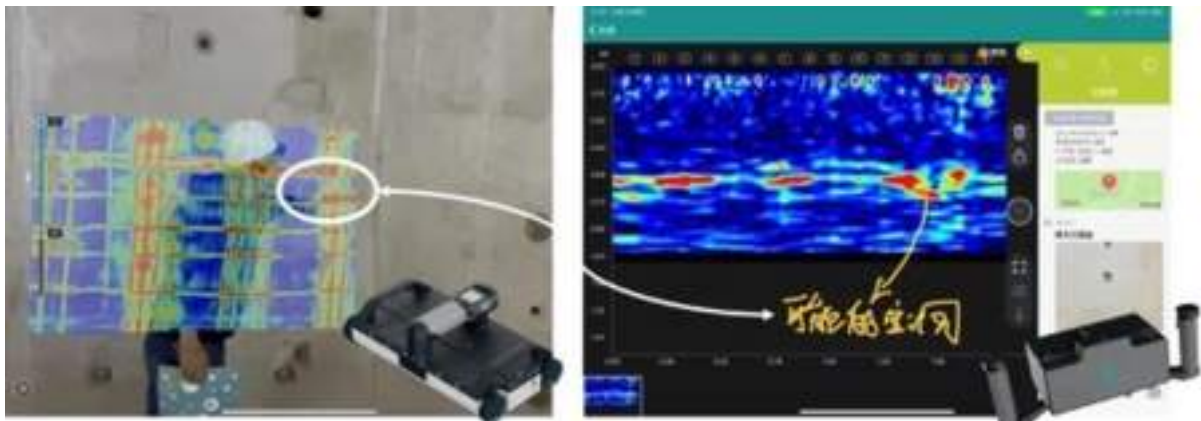
通过对 B 区的雷达 AR 结构观测，还发现钢筋与底板之间有明显的富水信号，存在渗水的可能（如左图红圈所示）。于是，我们利用 PD8050 寻找该区域渗水的原因。

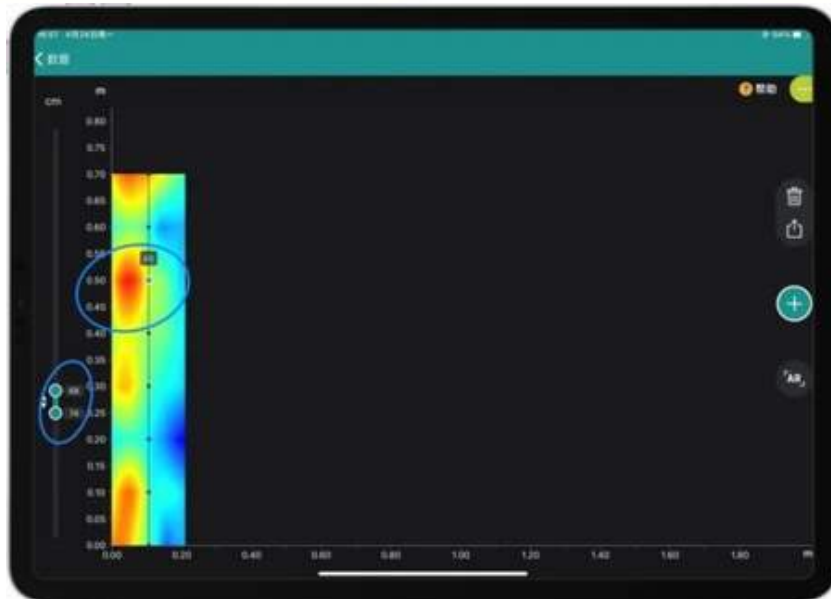
针对上述结果，我们继续使用 PD8050 对该区域进行全三维矩阵扫描，结果再次证实存在 68-74 厘米深处存在空洞。

The void position behind the base plate, with a depth of about 68-74 cm (shown by the blue circle in the figure)

根据我们的检测反馈，施工队将所有电子数据保存并共享给申报对象，并当场制定了 B 区的整改方案。
