## Bildgebung von Beton: Wie der technologieübergreifende Ansatz eine Inspektion von Weltklasse ermöglicht

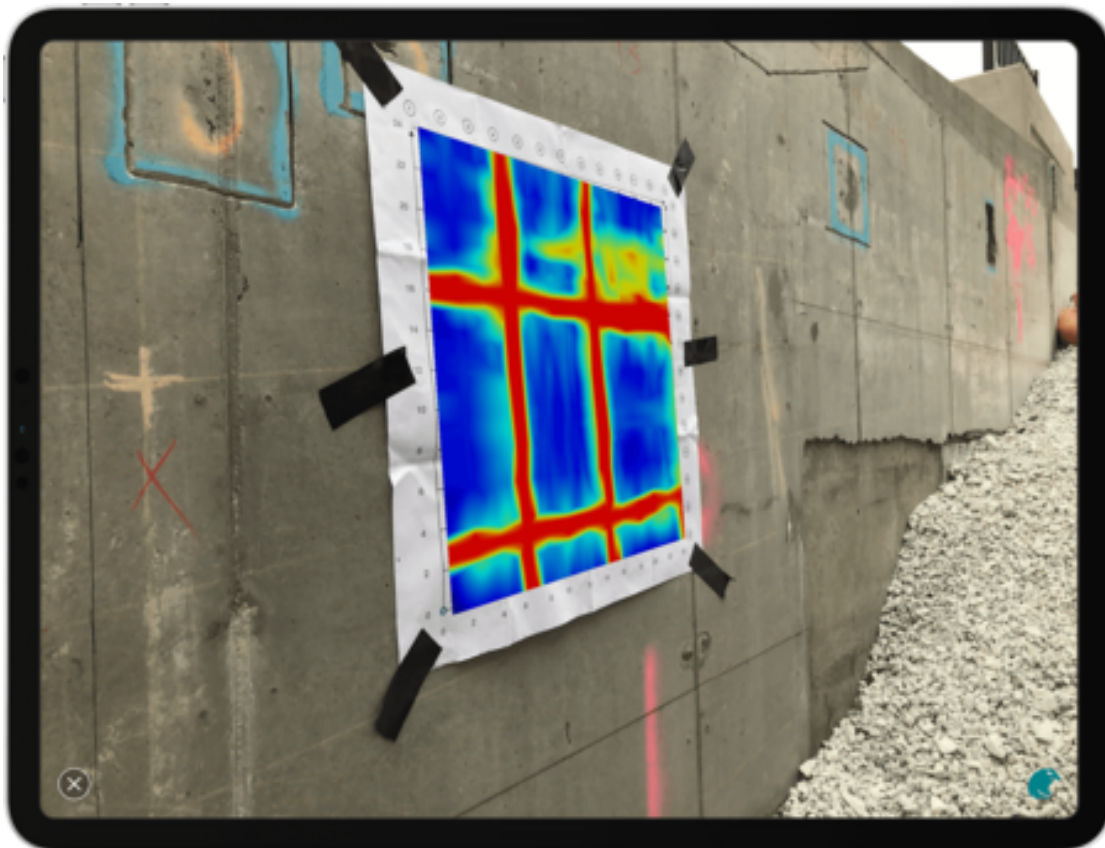
Proceq GP8000 results showing rebar and a large void (top right). The concrete was cored and the void was confirmed. It is an example of a consolidation void.
