Identifying Structural Damage on the Fukuoka Expressway Using MCGPR

Advanced Subsurface Assessment with the GS9000 Multichannel GPR

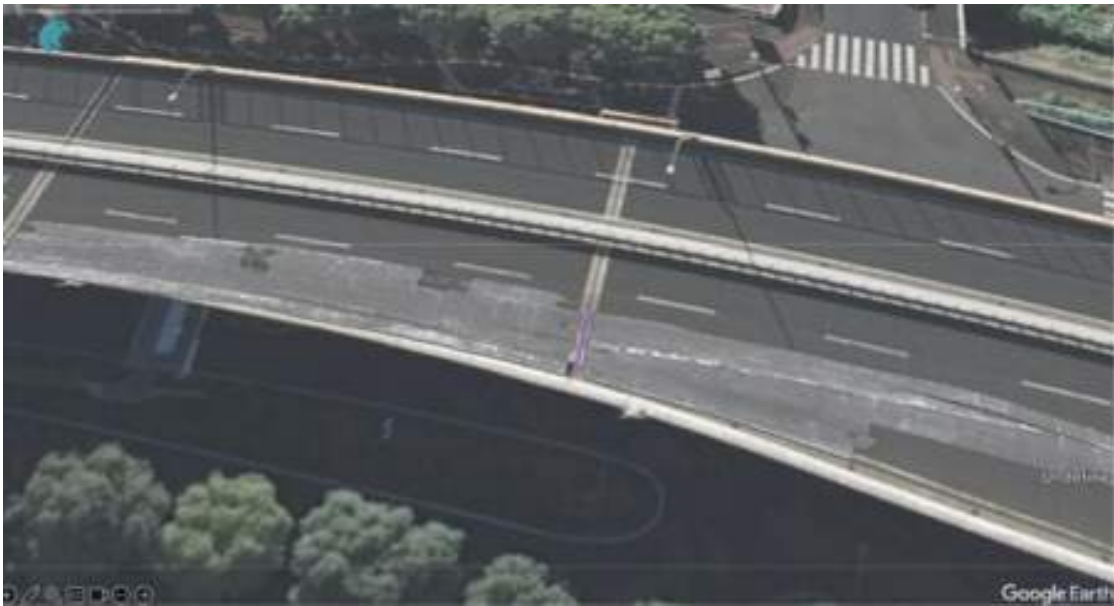
Figure 1. C-scan view overlaid in Google Earth, depicting the analysis of surface defects obtained from GPR Insights data collected by the GS9000.

The selected bridge sections for scanning were between expansion joints, with each section covering approximately 25 meters. A representative result is depicted in Figure 1, showing surface defects in a C-scan view overlaid in Google Earth.

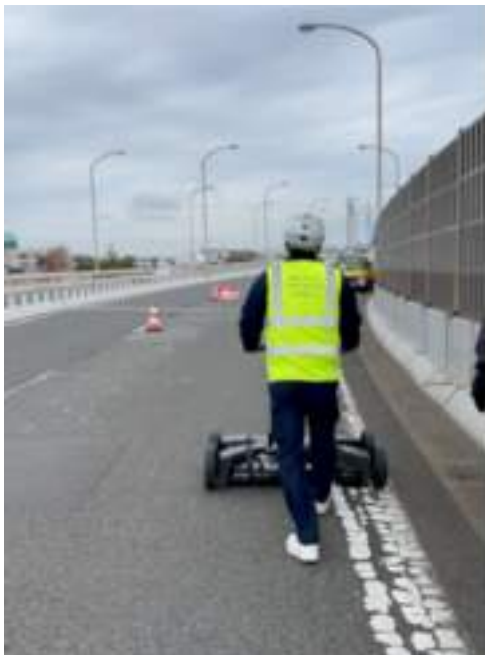
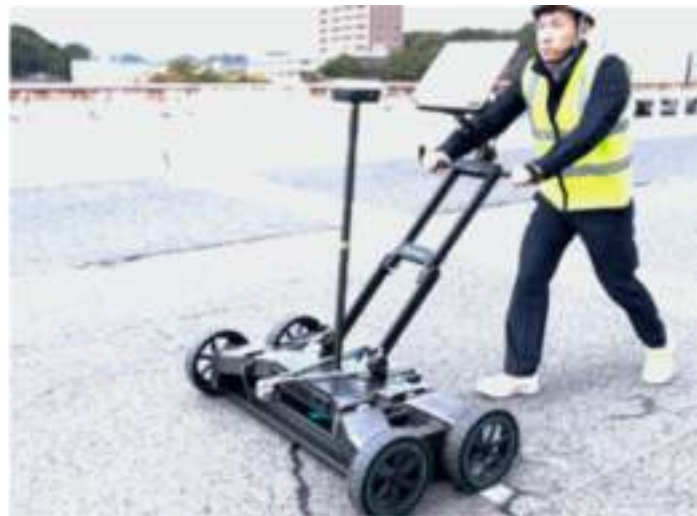
Figure 2 and Figure 3 show the GS9000 system operating on the bridge deck

Contrastingly, the GS9000 HF antenna introduces a pioneering design paradigm that deviates from the established norm. Notably, this innovative antenna design not only facilitates broader coverage across high-frequency spectra but also maintains a markedly reduced channel spacing of 2.5 cm. This departure from conventional spacing standards yields multifaceted advantages, profoundly impacting the capabilities and applications of GPR technology, as evidenced by this case study.

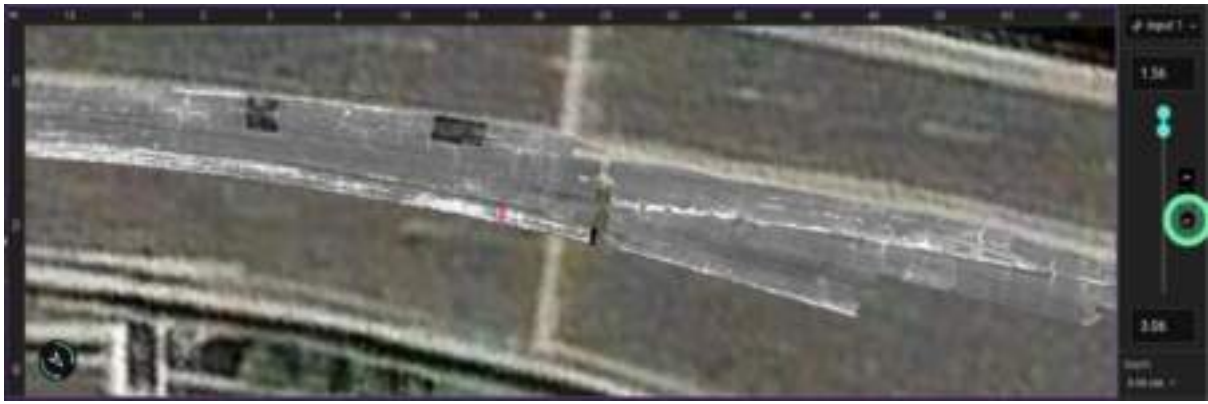
Figure 5. Major surface defects at asphalt layer (cracks)

Detailed reports based on scanning data provided valuable information for structural integrity assessments and maintenance planning. Simultaneously, through its high-frequency array antenna, engineers were able to collect dense data, identify structural weaknesses, and assess the extent of asphalt damage, including major cracks, and patterns indicative of potholes (Figure 2 and Figure 6).

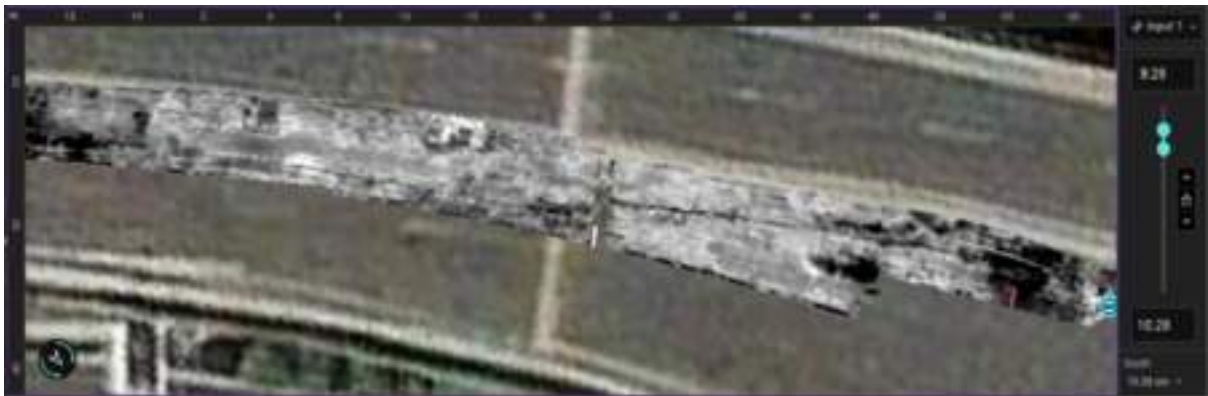
Figure 7. Interface defects between Asphalt-to-Concrete (A/C) layers (Delamination.)

They could also detect defects between asphalt and concrete layers, such as delamination, and to identify the deterioration areas attributed to scaling and decomposition in concrete constituents (Figure 7); and to analyze the first rebar layer (Figure 8), to create a further insightful condition map (Figure 4), pinpointing areas requiring immediate attention or maintenance.
