Durability Engineers: Condition Assessment of an Aging Pool Deck and Basement

Inspecting a 100-year-old swimming pool deck and basement with NDT

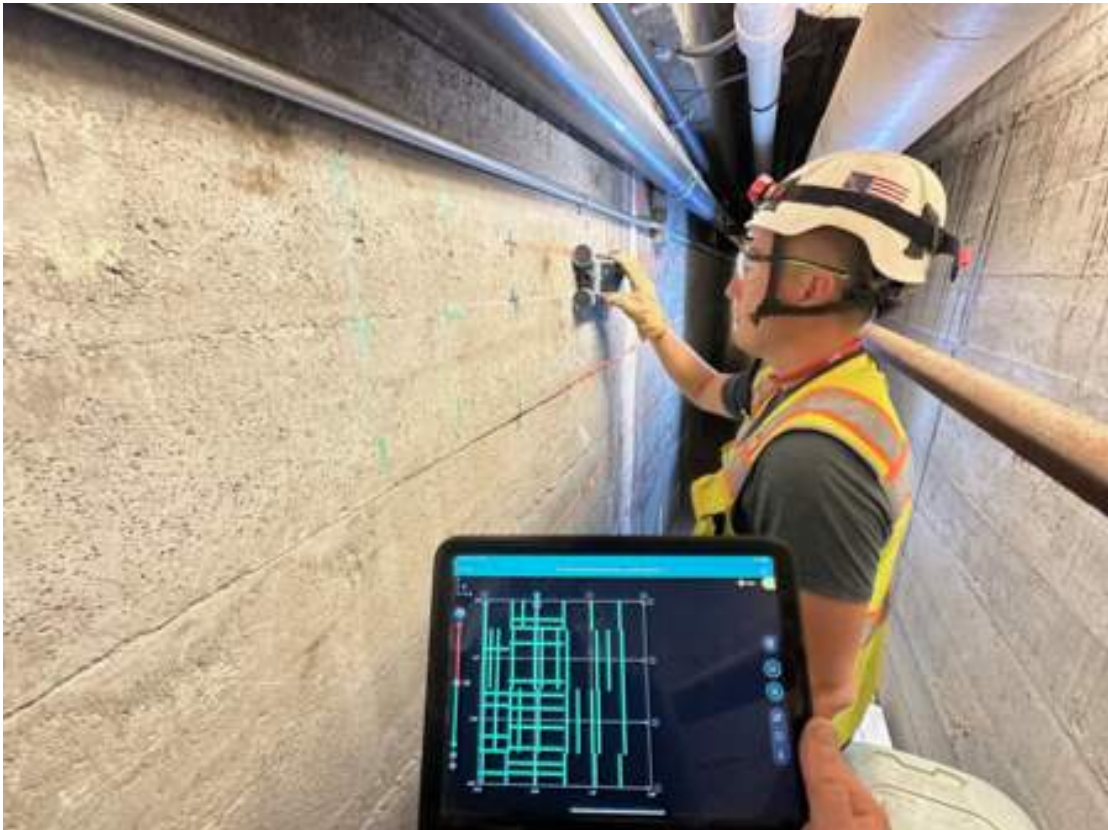
Reinforcement detailing with the Profometer PM8000 Pro cover meter, visualizing the results instantly on the iPad
