Identifying Potential Damage to PT Ducts on the Theodore Roosevelt Bridge, Florida

Explore the non-destructive testing methods used to locate and inspect post-tension ducts and tendons in bridges

The purpose of this project was to use non-destructive testing to locate PT tendon distresses identified with a permanent structural health monitoring system.

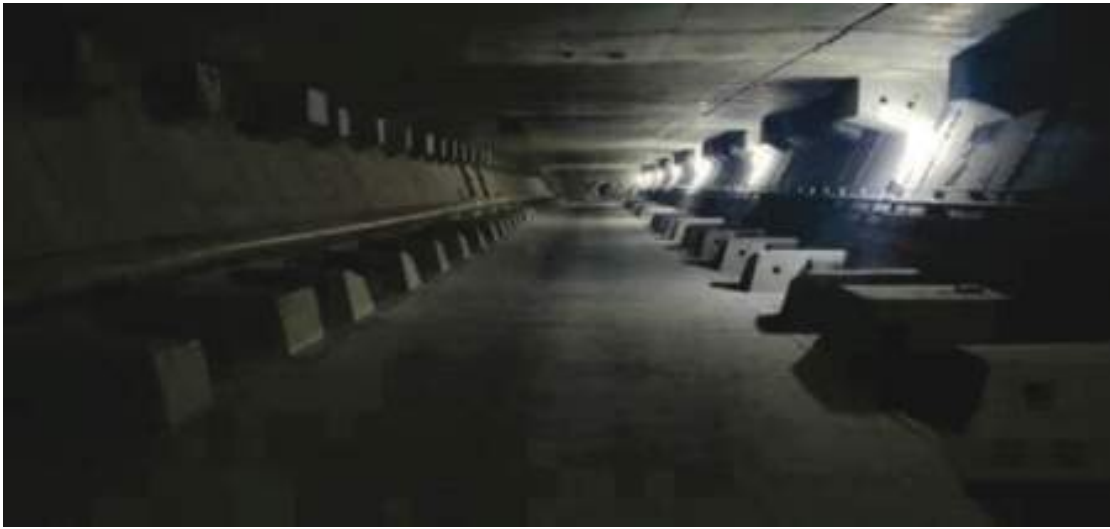
Figure 1. PT tendon locations inside the box beam

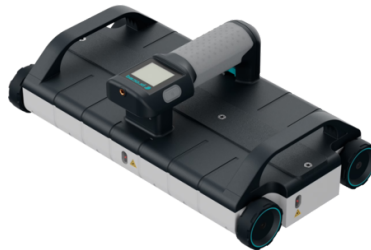
Screening Eagle has three versions of concrete GPR, but the GP8100 was primarily used in this project. This device has 6 antennas for larger area coverage and single pass C-scans (called superline scans) that allow for easier interpretation (Figure 2). C-scans allow visuals through the concrete depth, starting at the surface and slicing through the thickness.

Figure 2. Proceq GP8100
GPR

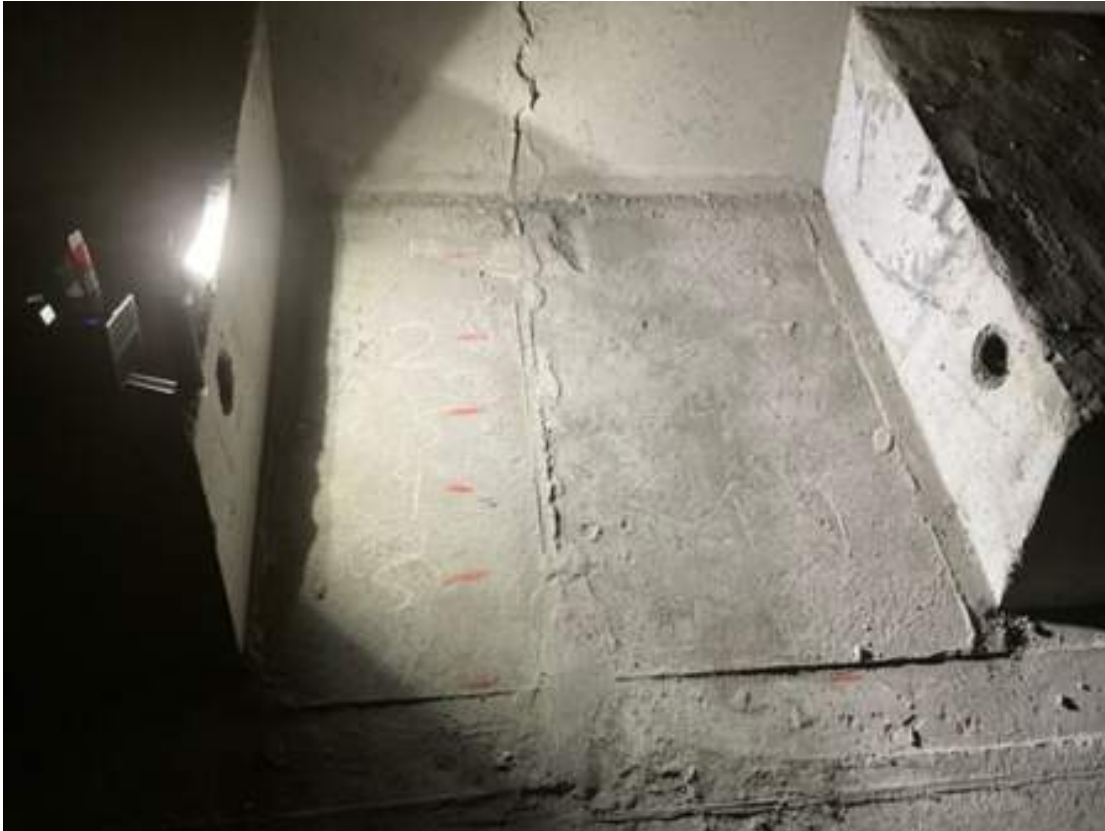
Figure 5

There is one line of snapshots per section composing the full scan and each scan is labeled on the top. The end of data snapshots corresponding to each tendon are identified with green markers (M1, M2, M3, etc.). In other words, the data for each tendon appears before the corresponding marker. Depending on surface conditions, a minimum of three snapshots were taken on each tendon at different locations.

Due to the overall surface roughness of the beam floor, the sixth tendon was not able to be scanned in all but one section. The x-axis can be used for distance measurement but in this instance, full gridding was disregarded in favor of inspection efficiency. The y-axis is the depth into the concrete with the surface being (0,0). There are many scans that identify the beam thickness at about 10 inches below the surface.
