Bolt inspection: Internal Defect Assessment & Data Management

This application note describes how to assess bolts on linear assets such as railway tracks.

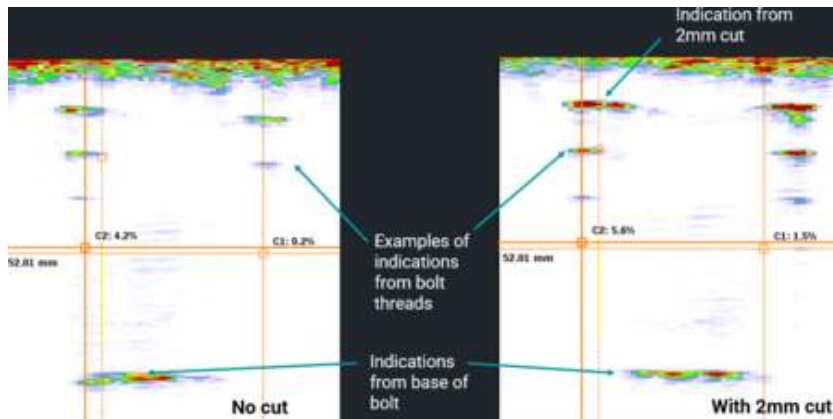
Phased array images from a bolt with no cut (left hand side) and a bolt with a 2mm cut (right hand side)

To test out the proposed solution, a defect was simulated using a 2 mm cut, just beneath the bolt head. Phased array testing was used to get images from the two bolts - one with no cuts and one with the 2mm cut. In the images, the bolt threads and base of the bolt can be identified. And in the bolt with the 2mm cut, an additional indication is visible from the 2mm cut. Further tests were conducted and it was concluded that ultrasonic array technology is a suitable approach for testing and sentencing bolts on-site.
