Efficient Detection of Corrosion in the Concrete floors of a Parking Garage

Nebest investigates large parking garage for corrosion using advanced half-cell potential technology

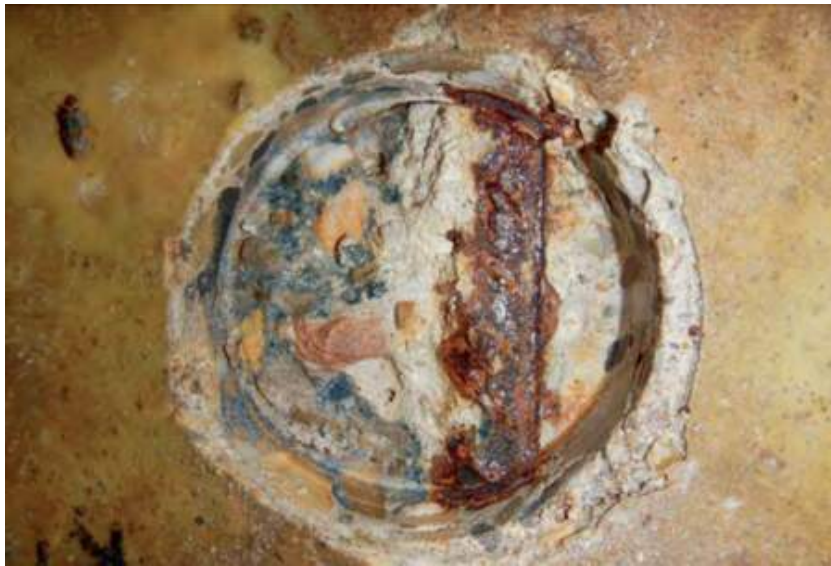
The floors of a parking garage under a former office building in the center of Rotterdam showed some local damage with compressed concrete. The building had been purchased by a property developer, who wanted to repurpose it as a high-end apartment complex.

Prior to the large-scale renovation of the complex, a good insight into the condition of the parking garage, investigation was needed in order to determine the nature and extent of the necessary maintenance measures.

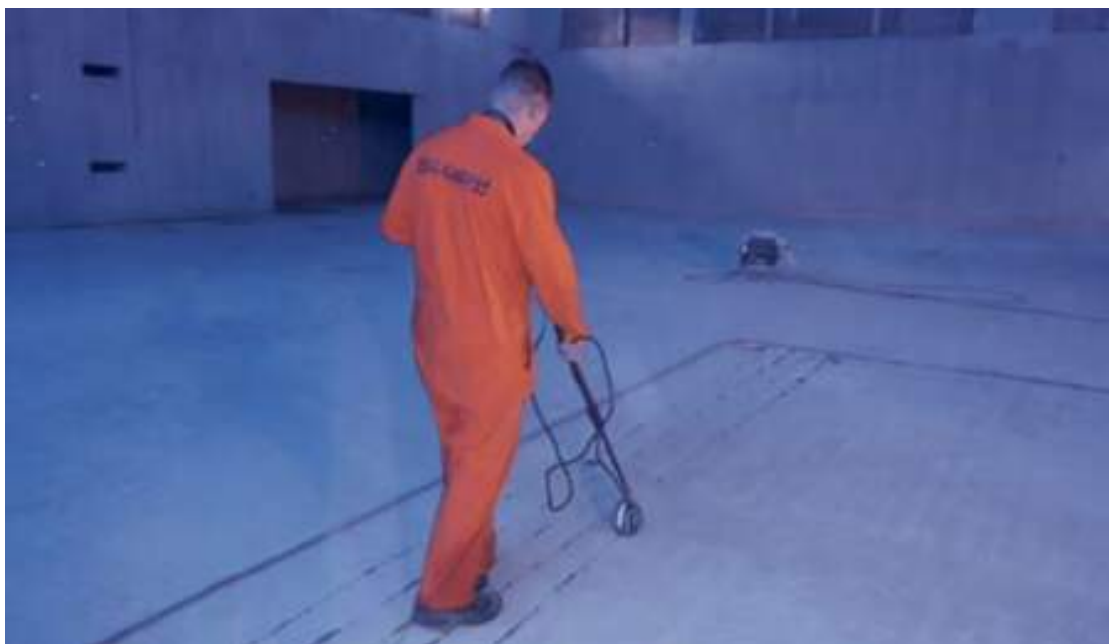
With the PM8500 half-cell potential meter, a lot of insight can be gained into the corrosion activity in a construction in a relatively short period of time. This technique is based on measuring the stress differences (potential differences) that occur during active corrosion. In places where a low potential (more negative potential) is measured, there may be a corrosion hot spot.

Performing half-cell potential measurements on the concrete floor with the Profometer PM8500 corrosion sensor
