Identifying Structural Damage on the Fukuoka Expressway Using MCGPR

Advanced Subsurface Assessment with the GS9000 Multichannel GPR

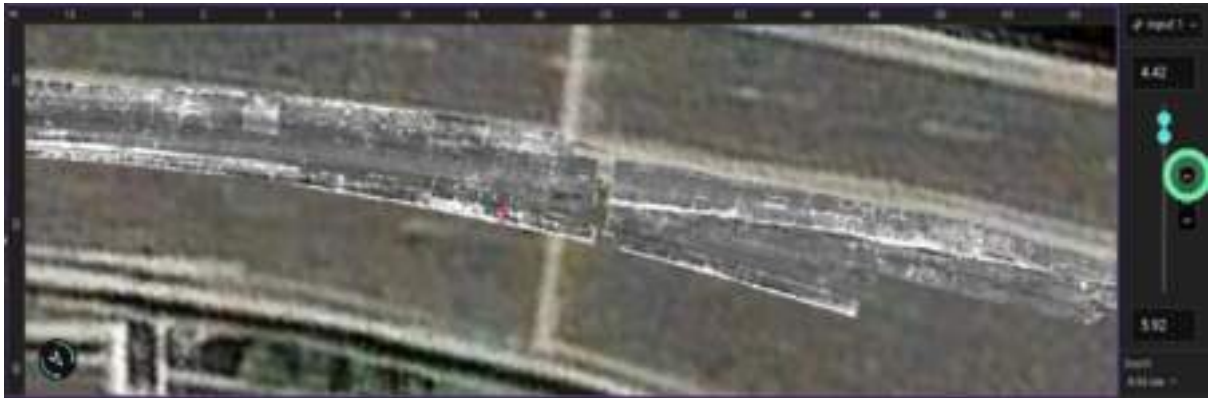
Figure 6. Extended surface layer defects were found at depths of 4 to 6 cm within the asphalt layer.

Detailed reports based on scanning data provided valuable information for structural integrity assessments and maintenance planning. Simultaneously, through its high-frequency array antenna, engineers were able to collect dense data, identify structural weaknesses, and assess the extent of asphalt damage, including major cracks, and patterns indicative of potholes (Figure 2 and Figure 6).

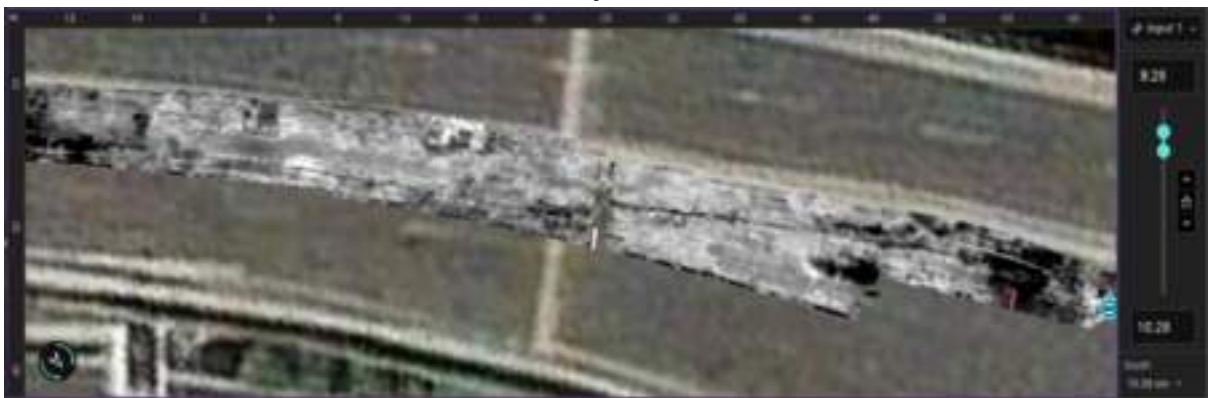
Figure 7. Interface defects between Asphalt-to-Concrete (A/C) layers (Delamination.)

They could also detect defects between asphalt and concrete layers, such as delamination, and to identify the deterioration areas attributed to scaling and decomposition in concrete constituents (Figure 7); and to analyze the first rebar layer (Figure 8), to create a further insightful condition map (Figure 4), pinpointing areas requiring immediate attention or maintenance.
