Bolt inspection: Internal Defect Assessment & Data Management

This application note describes how to assess bolts on linear assets such as railway tracks.

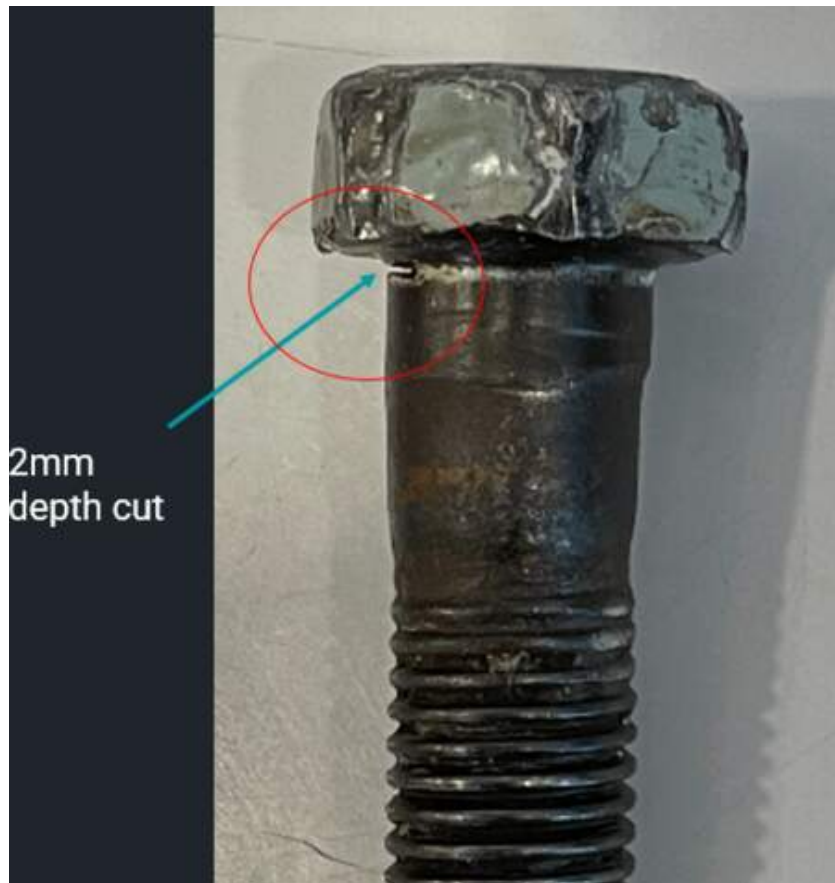
Bolt with a 2mm depth cut to simulate a defect.

To test out the proposed solution, a defect was simulated using a 2 mm cut, just beneath the bolt head. Phased array testing was used to get images from the two bolts - one with no cuts and one with the 2mm cut. In the images, the bolt threads and base of the bolt can be identified. And in the bolt with the 2mm cut, an additional indication is visible from the 2mm cut. Further tests were conducted and it was concluded that ultrasonic array technology is a suitable approach for testing and sentencing bolts on-site.
