# Durability Engineers: Condition Assessment of an Aging Pool Deck and Basement

## Inspecting a 100-year-old swimming pool deck and basement with NDT

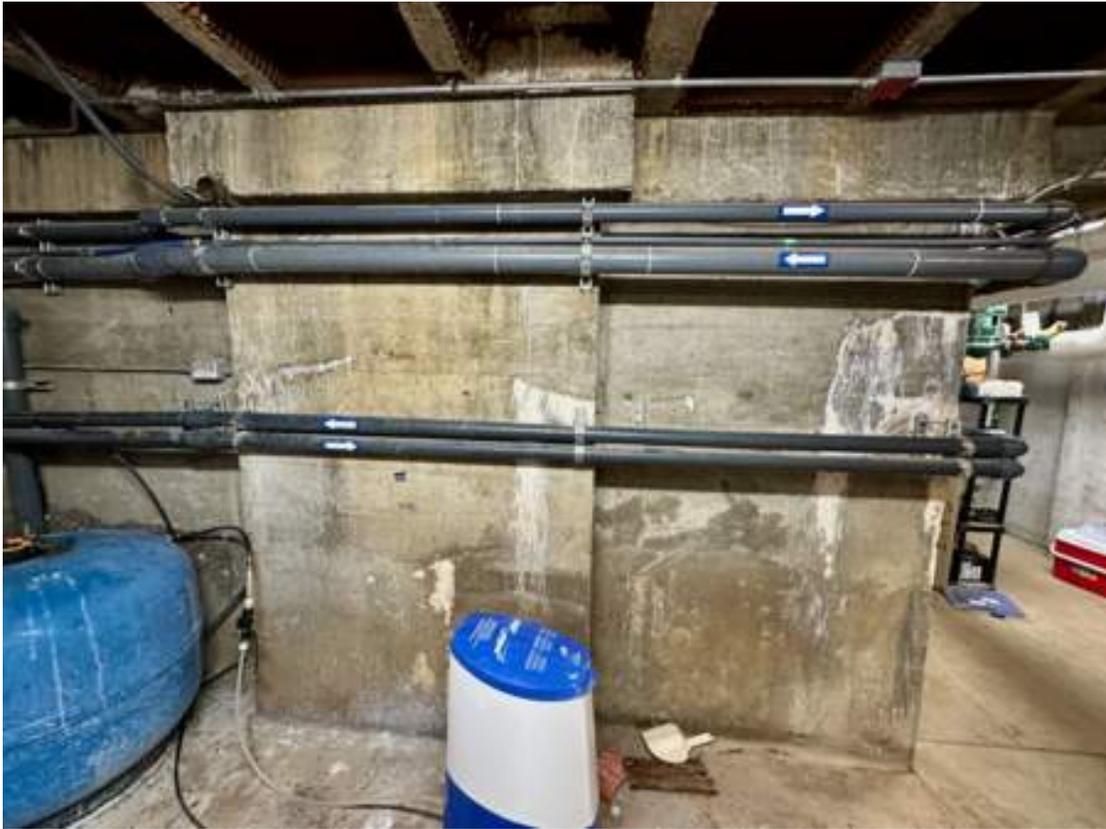
In a U.S. municipality building in Michigan, issues were encountered with the aging infrastructure of the pool deck and surrounding sub-grade basement. Originally constructed in 1926, the pool deck exhibited signs of extensive deterioration, primarily due to water intrusion over the years.

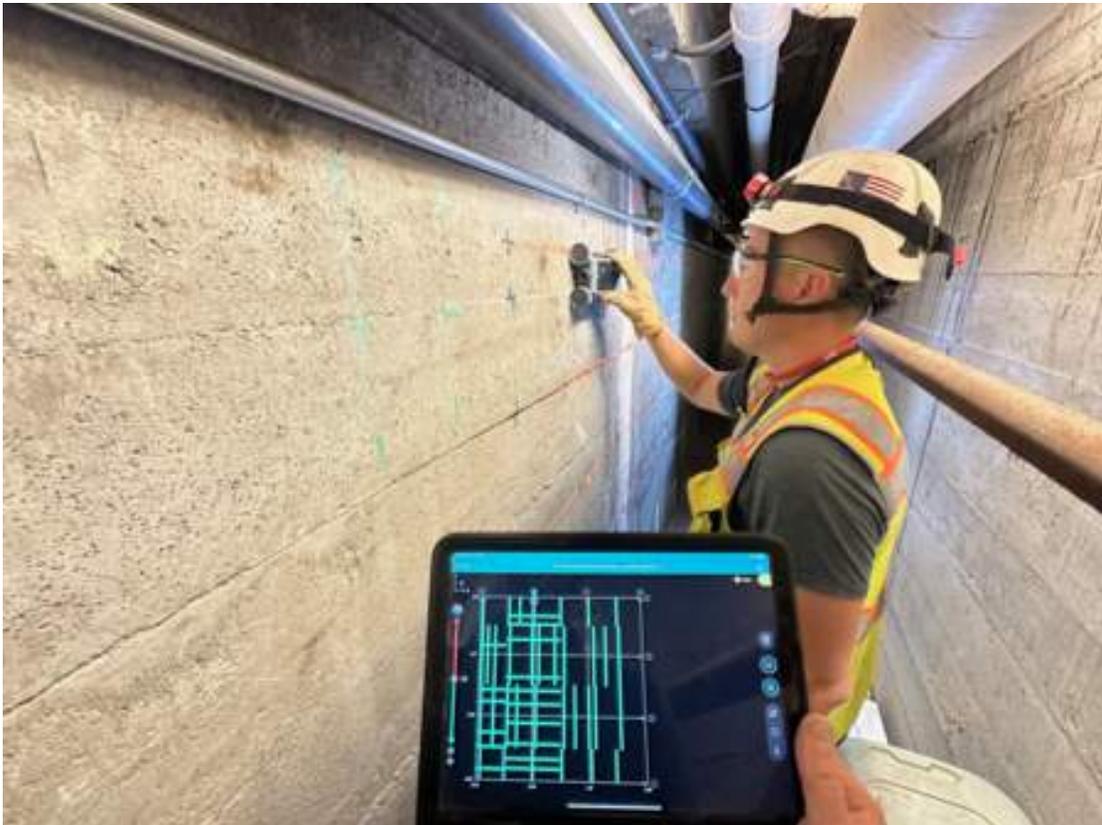
Reinforcement detailing with the Profometer PM8000 Pro cover meter, visualizing the results instantly on the iPad

- o **Cover Meter:** [Profometer PM8000 Pro](#) rebar and cover meter was used to assess the as-built conditions of the concrete throughout the basement, determining approximate size, orientation, and depth of steel reinforcement and support the core extraction process.
