Figure 1. PT tendon locations inside the box beam

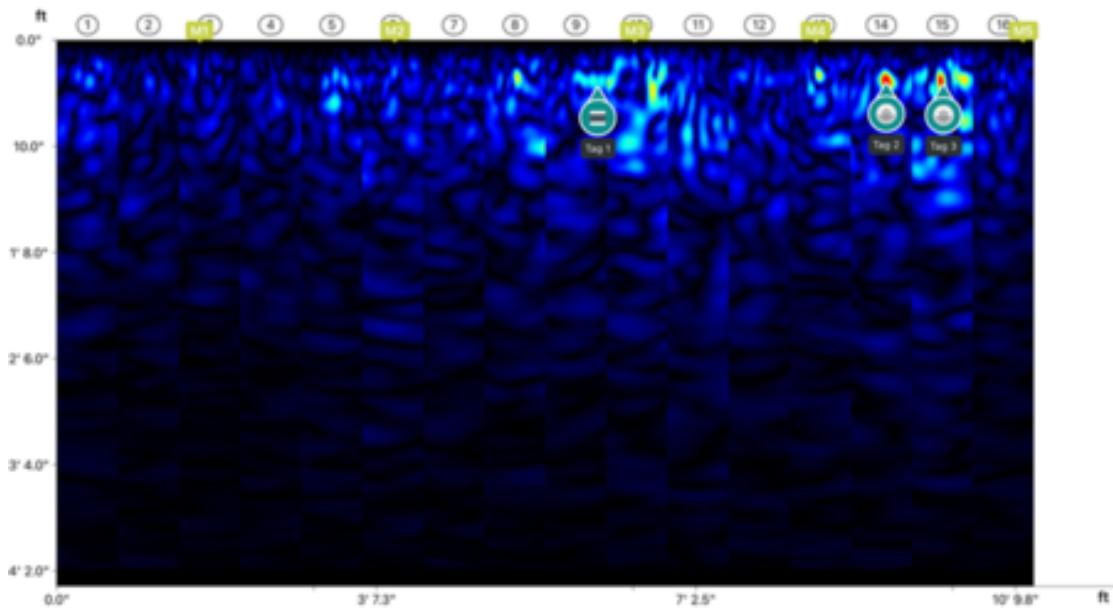
Figure 7: UPE scan
