Bolt inspection: Internal Defect Assessment & Data Management

This application note describes how to assess bolts on linear assets such as railway tracks.

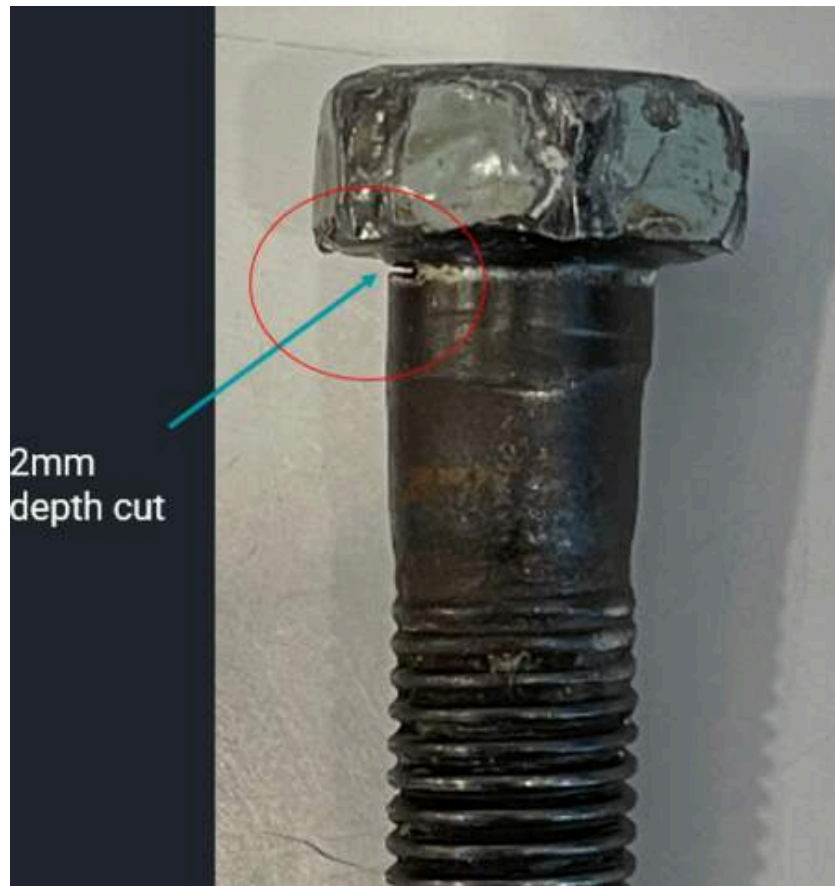
Bolt with a 2mm depth cut to simulate a defect.

To test out the proposed solution, a defect was simulated using a 2 mm cut, just beneath the bolt head. Phased array testing was used to get images from the two bolts - one with no cuts and one with the 2mm cut. In the images, the bolt threads and base of the bolt can be identified. And in the bolt with the 2mm cut, an additional indication is visible from the 2mm cut. Further tests were conducted and it was concluded that ultrasonic array technology is a suitable approach for testing and sentencing bolts on-site.

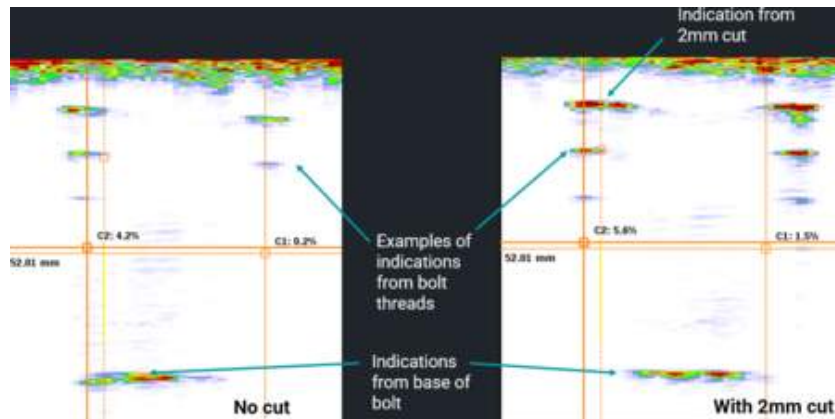
Phased array images from a bolt with no cut (left hand side) and a bolt with a 2mm cut (right hand side)
