Imaging del calcestruzzo: Come l'approccio multi-tecnologico facilita l'ispezione di livello mondiale

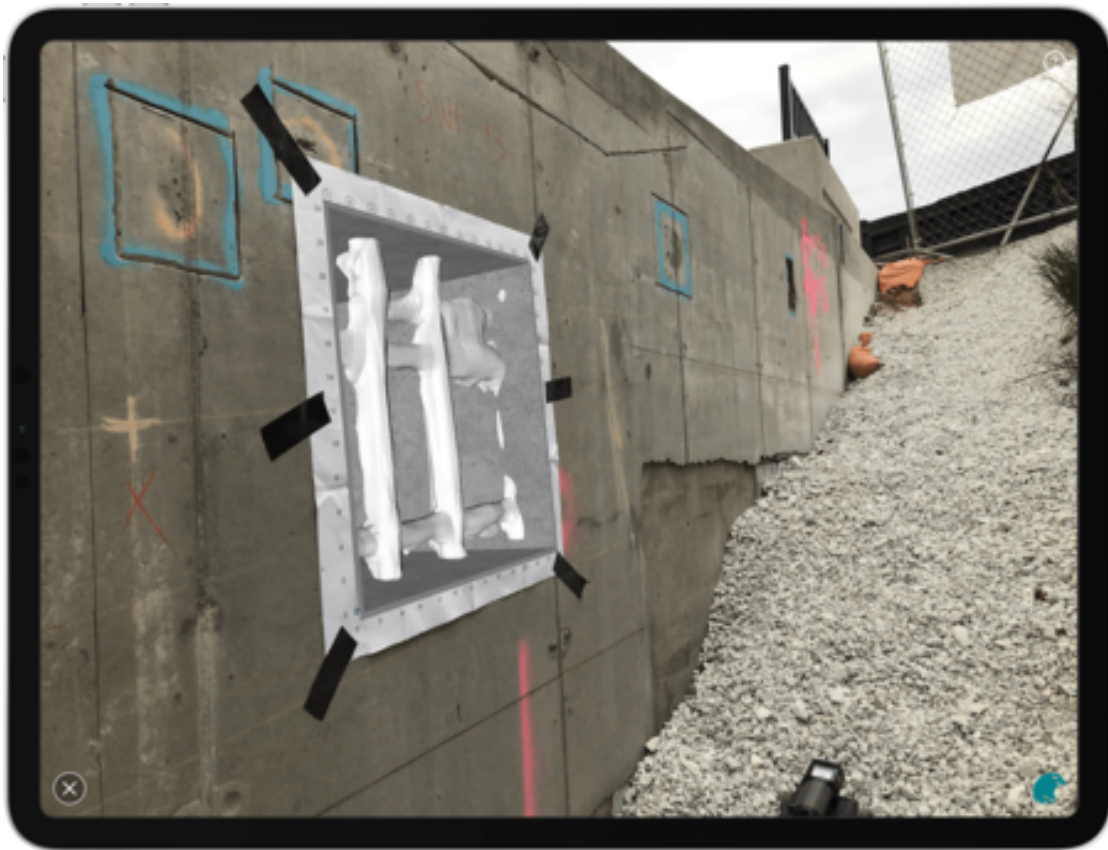
Proceq GP8000 results showing rebar and a large void (top right). The concrete was cored and the void was confirmed. It is an example of a consolidation void.
