Figure 1. PT tendon locations inside the box beam

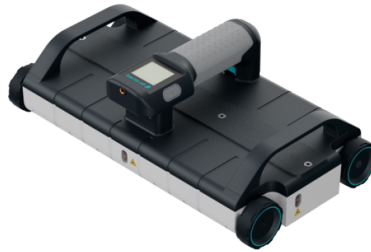
Figure 2. Proceq GP8100  
GPR

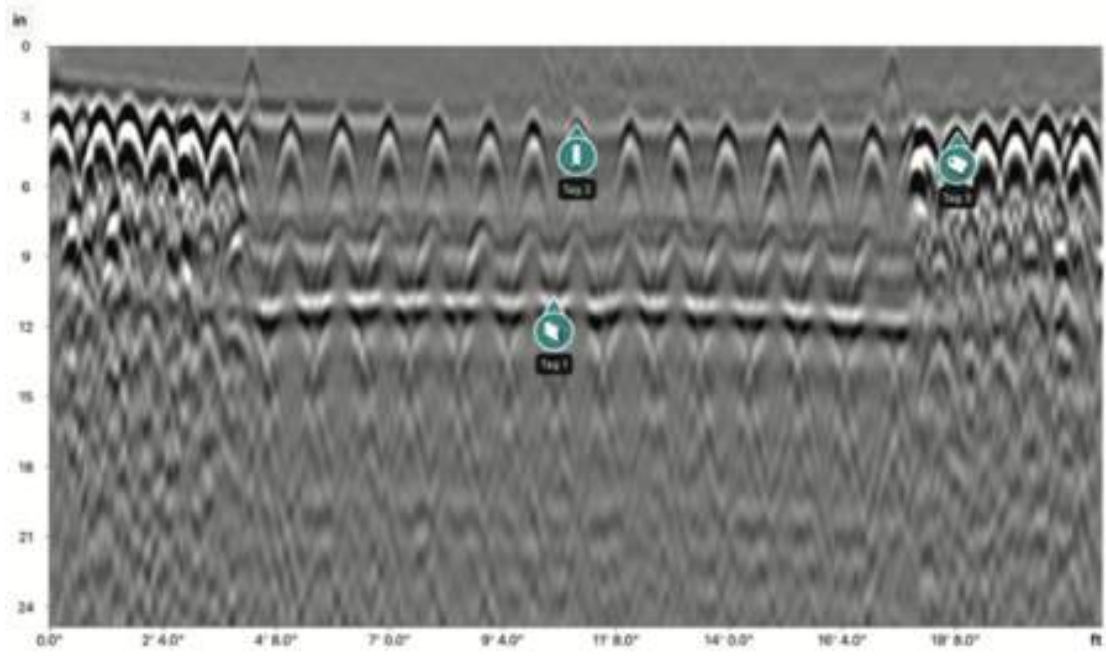
Figure 4: GPR scan across box girder width.

- Rebar
- Non Metallic
- Backwall
- Void
- Live Wire

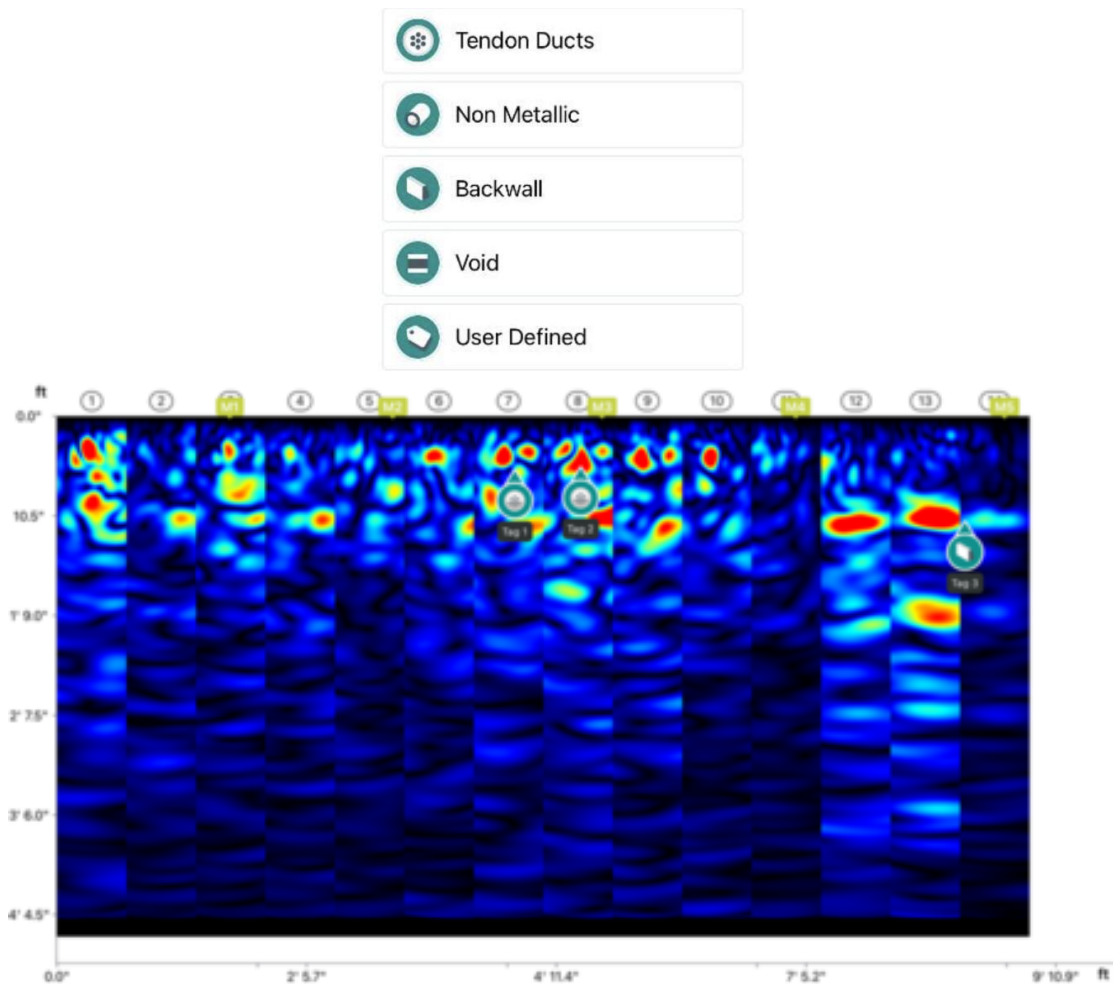
Figure 8: UPE scan
