# Efficient Concrete Assessments in Complex Operating Environments

## Study 1 - Multi-storey building

## Study 2 - Radiotherapy bunker

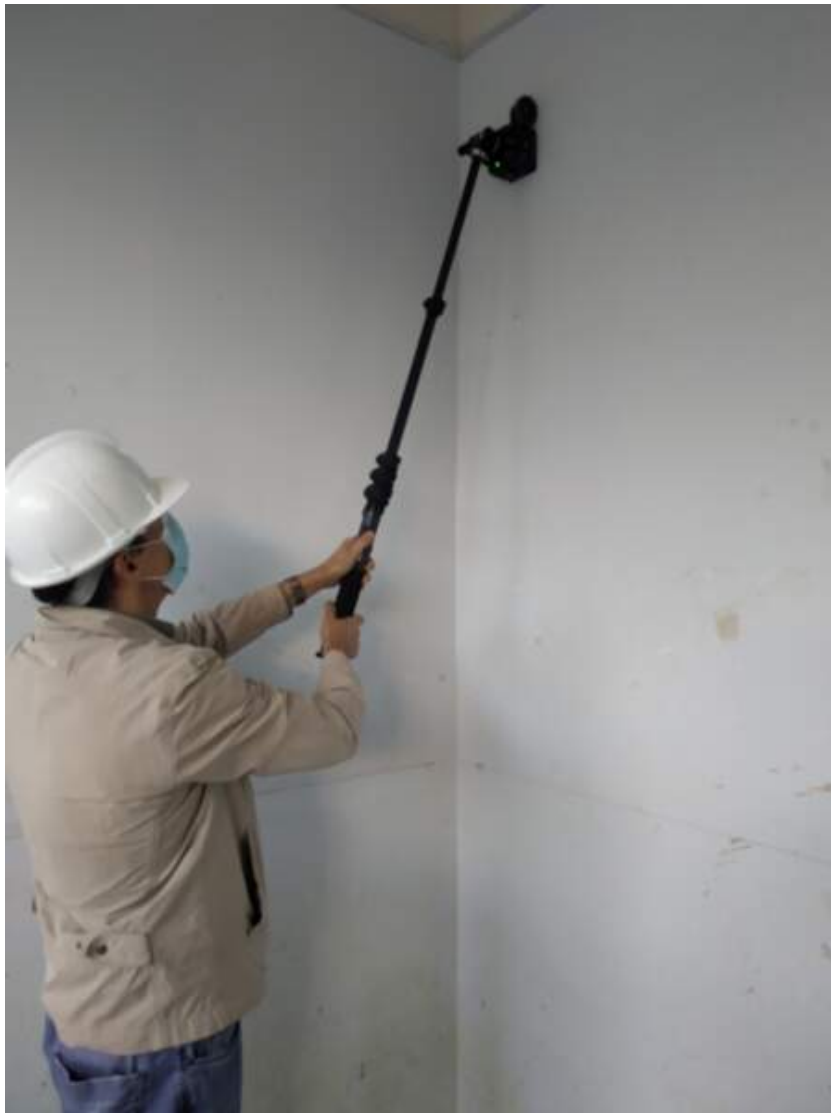
The subject of the other study [2] was a radiotherapy bunker constructed in the 1980s and located in a hospital in Spain. It houses equipment for cancer treatment and the concrete performs as insulation, preventing possible radioactivity emissions beyond the shielding of the equipment itself. Concrete used for this purpose must be thick and dense. Insufficient information on the structure was available in documentation. However, a recent adaptation of the bunker to accommodate new equipment allowed investigators to thoroughly test one wall and they found it to be a double wall with layers of conventional concrete and barite concrete. The latter is commonly used in radiotherapy bunkers and it includes barite instead of conventional aggregate because of the additional density that this provides.
