Identifying Structural Damage on the Fukuoka Expressway Using MCGPR

Advanced Subsurface Assessment with the GS9000 Multichannel GPR

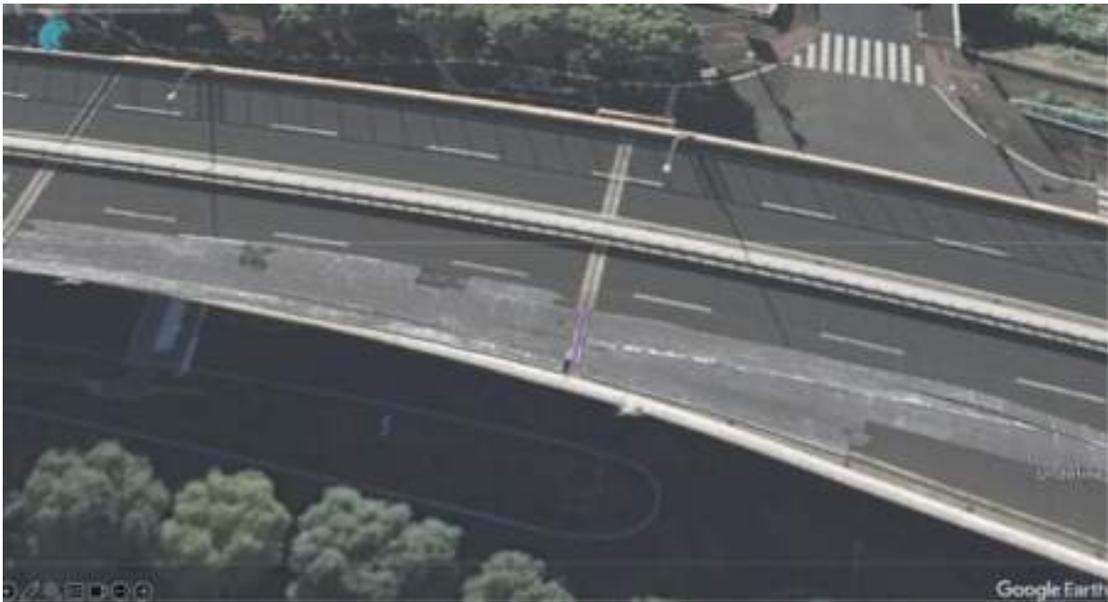
The selected bridge sections for scanning were between expansion joints, with each section covering approximately 25 meters. A representative result is depicted in Figure 1, showing surface defects in a C-scan view overlaid in Google Earth.

Figure 1. C-scan view overlaid in Google Earth, depicting the analysis of surface defects obtained from GPR Insights data collected by the GS9000.

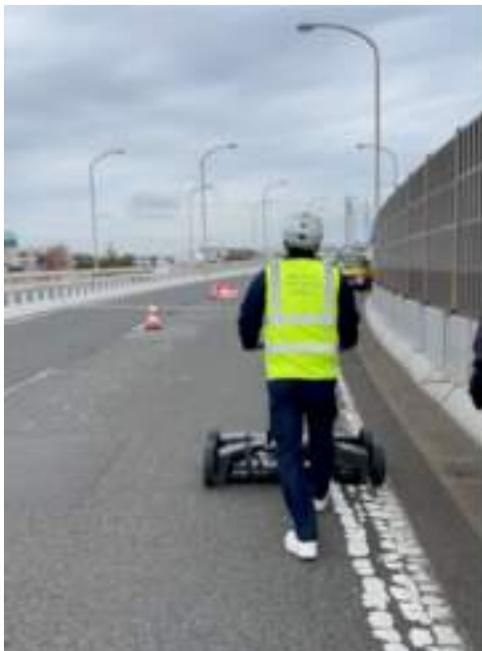
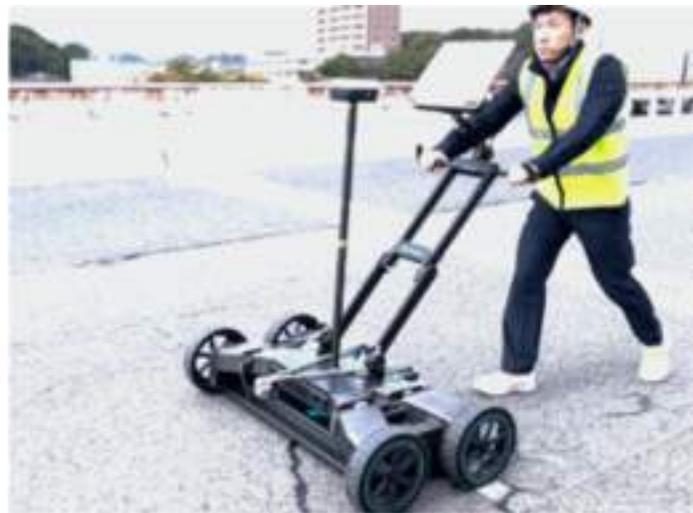
Figure 2 and Figure 3 show the GS9000 system operating on the bridge deck

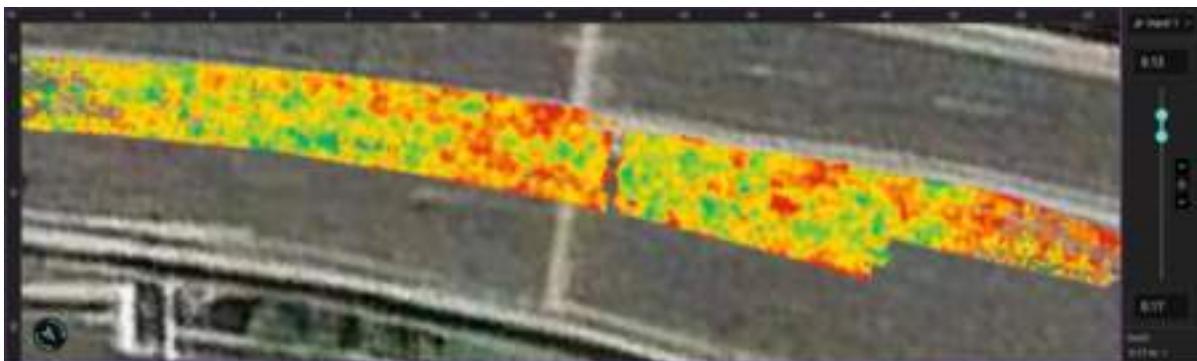
GPR mapping, particularly with extremely dense data collected by MCGPR GS9000, generates a Deterioration Map based on analysing amplitude degradation of the top reinforcement bars (rebar) within bridge structures. By emitting electromagnetic pulses and assessing the attenuation of reflected signals from rebar, GPR reveals insights into structural deterioration, aligned with ASTM D6087 standards. Traditionally, manual analysis of GPR data is labour-intensive and time-consuming. To overcome this, an AI engine autonomously detects rebar apexes, facilitating uninterrupted GPR application use.

1. Likelihood of Deterioration Maps (Figure 4): These maps are computed following the ASTM D6087 standard, providing an assessment of the likelihood of concrete deterioration in bridge deck. This information helps in identifying areas that require closer inspection or potential maintenance interventions.
2. Condition Maps for Generic Reinforced Concrete Elements: These maps provide an overview of the condition of the generic reinforced concrete elements within the bridge deck. They offer valuable insights into the overall state of the infrastructure, enabling informed decision-making for maintenance and repair activities.

Figure 4. The most significant output of GPR mapping results is the Deterioration Map, based on the amplitude degradation of the top rebar.

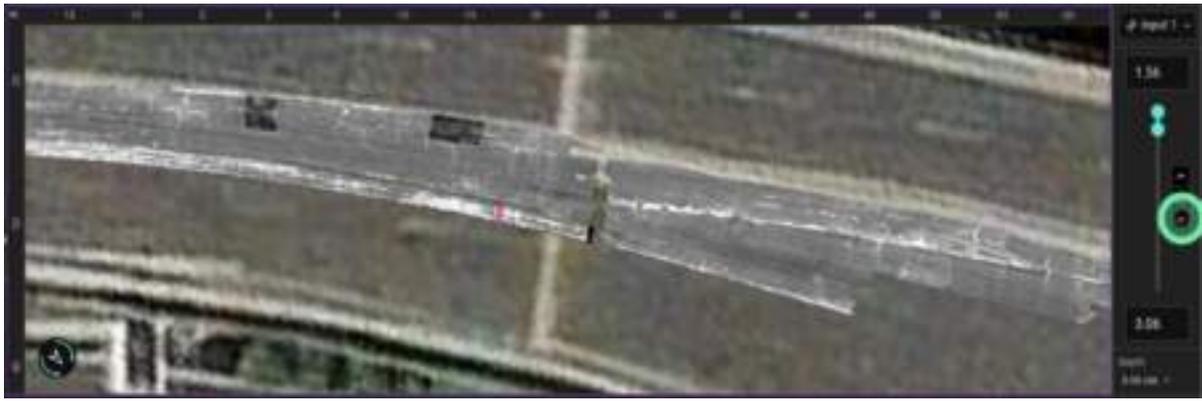
Detailed reports based on scanning data provided valuable information for structural integrity assessments and maintenance planning. Simultaneously, through its high-frequency array antenna, engineers were able to collect dense data, identify structural weaknesses, and assess the extent of asphalt damage, including major cracks, and patterns indicative of potholes (Figure 2 and Figure 6).

Figure 5. Major surface defects at asphalt layer (cracks)

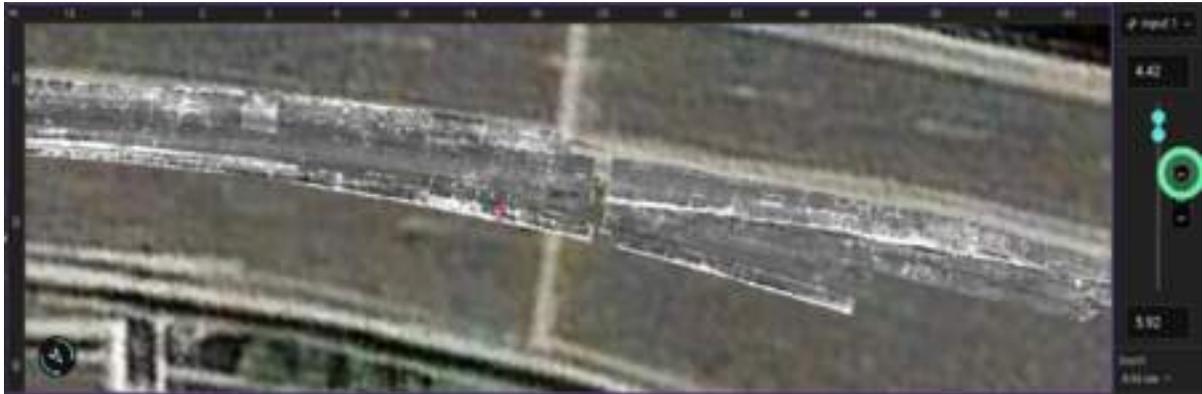
Figure 6. Extended surface layer defects were found at depths of 4 to 6 cm within the asphalt layer.

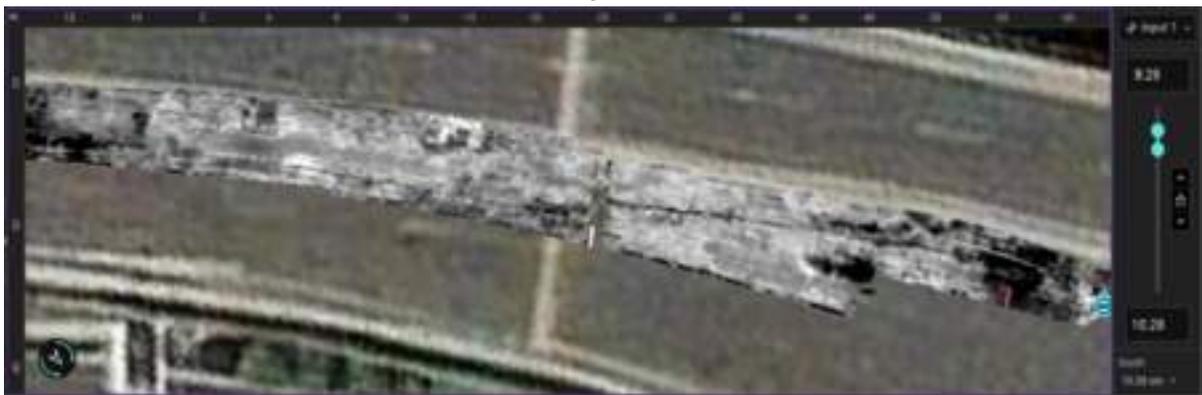
They could also detect defects between asphalt and concrete layers, such as delamination, and to identify the deterioration areas attributed to scaling and decomposition in concrete constituents (Figure 7); and to analyze the first rebar layer (Figure 8), to create a further insightful condition map (Figure 4), pinpointing areas requiring immediate attention or maintenance.

Figure 7. Interface defects between Asphalt-to-Concrete (A/C) layers (Delamination.)

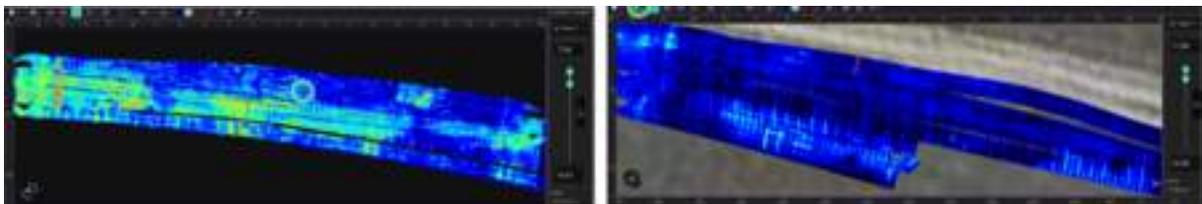
Figure 8. Live-Slice view of the first layer rebar mesh.
