# Durability Engineers: Condition Assessment of an Aging Pool Deck and Basement

## Inspecting a 100-year-old swimming pool deck and basement with NDT

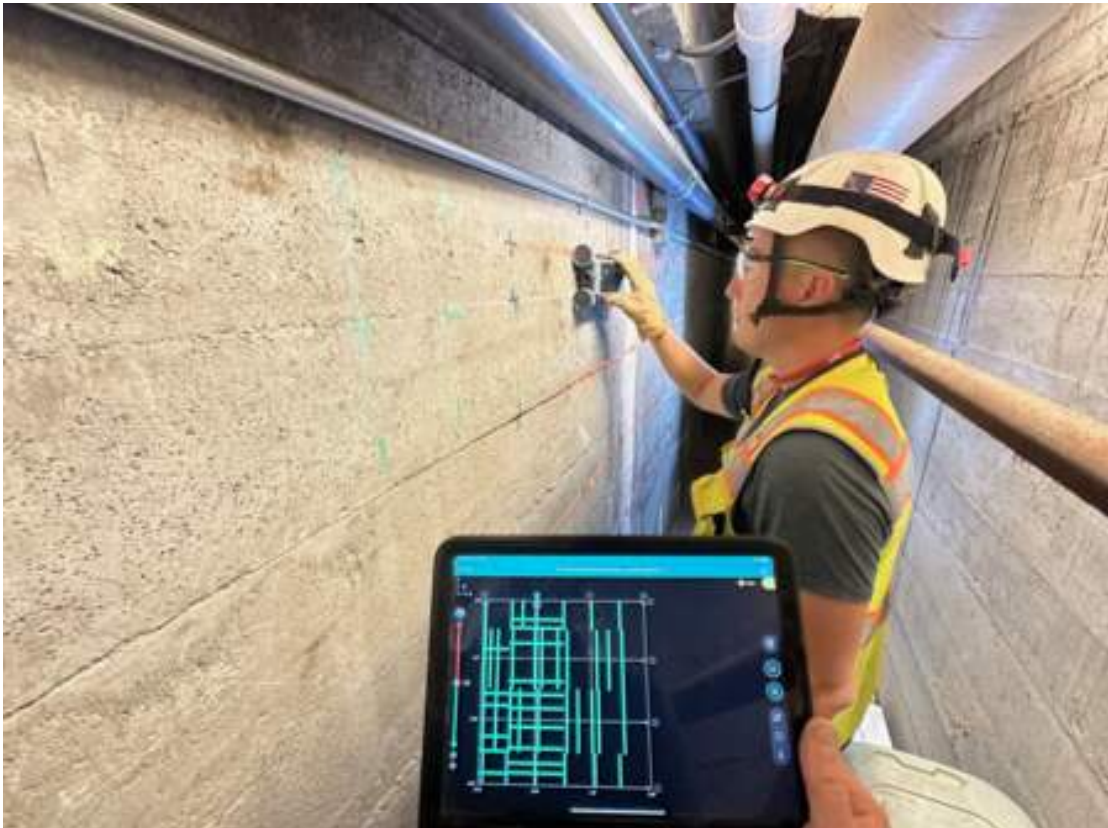
- o **Cover Meter:** [Profometer PM8000 Pro](#) rebar and cover meter was used to assess the as-built conditions of the concrete throughout the basement, determining approximate size, orientation, and depth of steel reinforcement and support the core extraction process.

Reinforcement detailing with the Profometer PM8000 Pro cover meter, visualizing the results instantly on the iPad
