如何使用 GPR 和超声波检查新建隧道的渗水点？

测试结果 - B 区

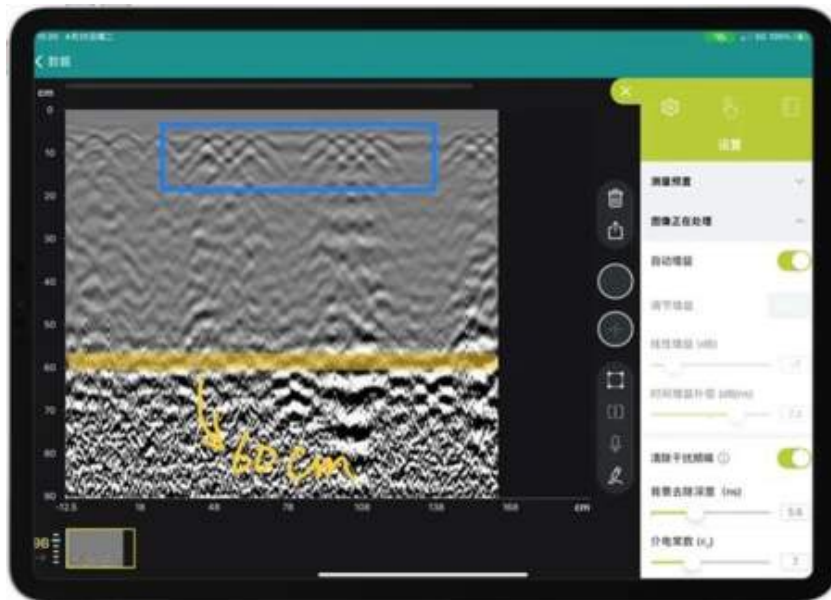
GP8100 radar cross section diagram

从雷达截面图来看，7~13 厘米深度内的倒双曲线形（蓝色框）主要是由双层钢筋网信号反射引起的。在深度约 60 厘米处（黄色标记线），连续的板反射信号主要由混凝土初始分支（板厚）的信号反射引起。钢筋与底板深度之间没有明显的富水信号。

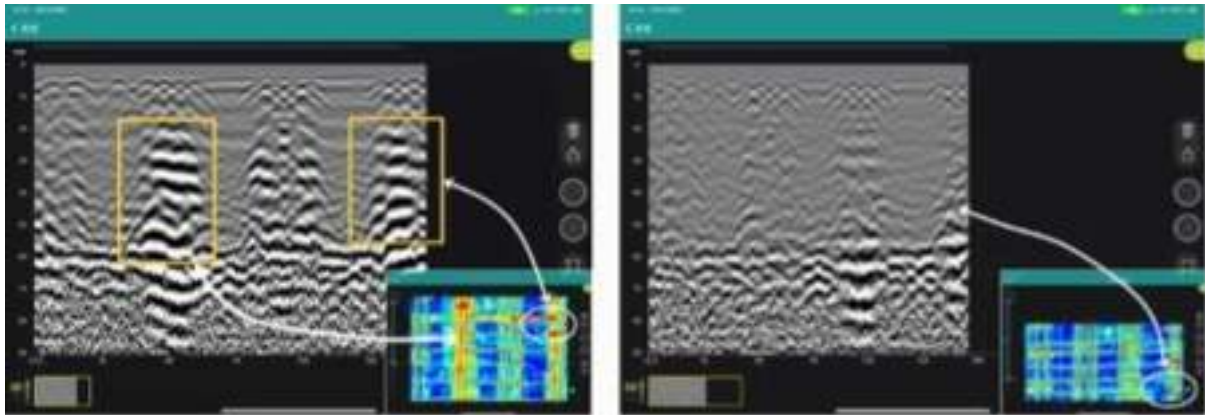
Comparison of Radar Line Scanning in Zone A and Zone B

左图为 B 区 8 号线剖面图，右图为 A 区 9 号线剖面图。从两张图的对比来看，A 区没有富水或渗水现象，B 区钢筋与楼板之间有明显的富水信号。
