# Assessing Fire Damage in Steel Structures

## Metal hardness testing devices in fire damage assessment

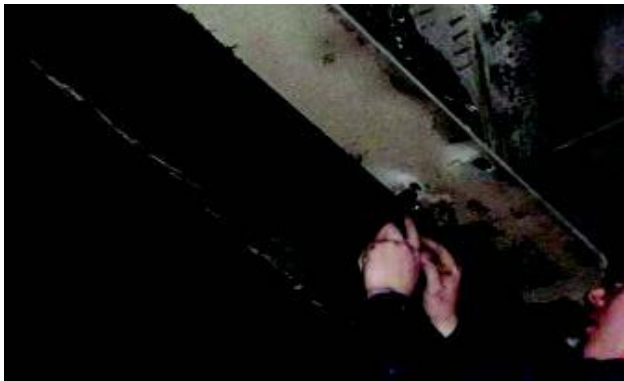
Following a suspicious fire incident during the school's construction, visual inspections suggested potential deformation of a steel beam. However, uncertainty lingered regarding the extent of damage caused by the fire.

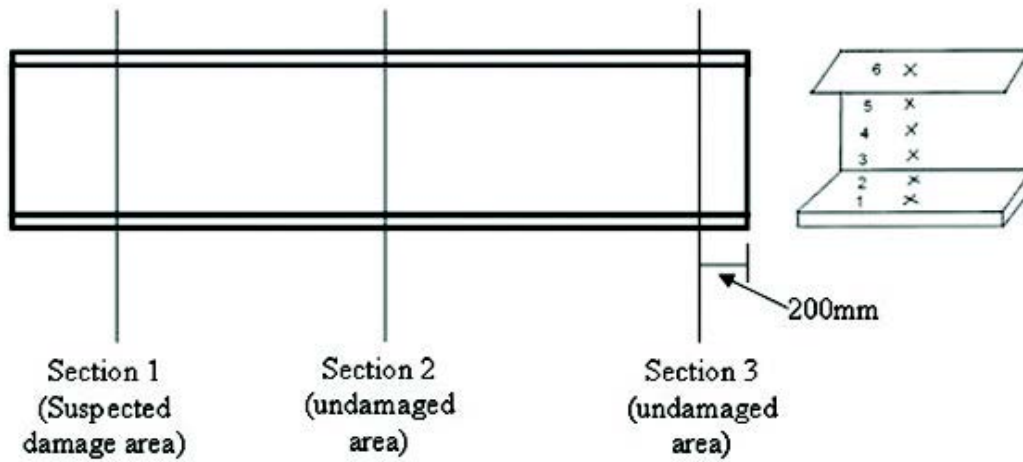
The hardness test results revealed that the steel beam retained its original design strength of 275 N/mm<sup>2</sup> post-fire. The average Vickers hardness numbers ranged from 127 to 172, well within the acceptable limits for grade 275 tested steel. Notably, the hardness values at the top flange were relatively higher than those in the web and bottom flange. This indicates that the steel beam maintained its integrity despite the fire damage, retaining a 60-minute fire resistance rating.
