Rebar Location at Portland Oregon International Airport (PDX)

Overview

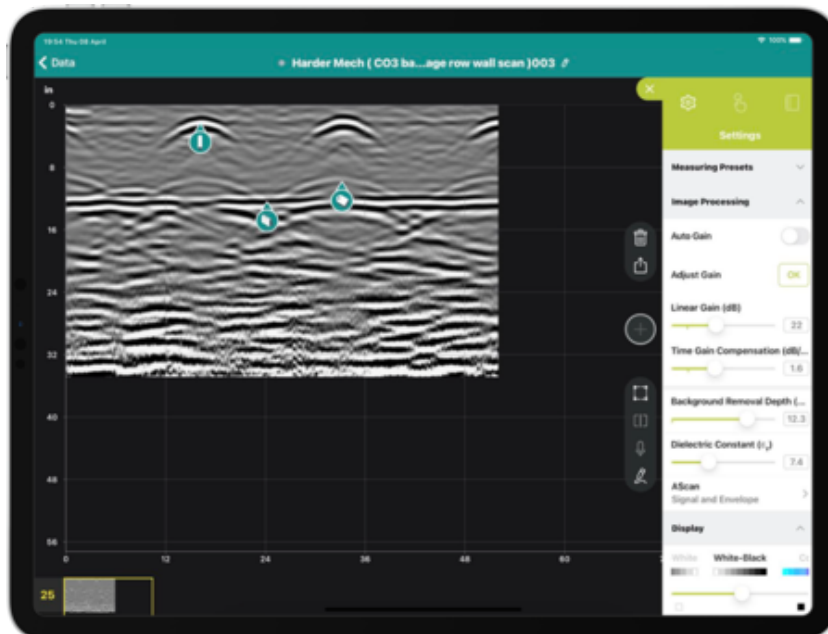
Bedrock Concrete Cutting was called for help. Bedrock Concrete Cutting is a full service, concrete cutting and drilling contractor. Bedrock rose to the challenge by not only providing the skill and equipment to execute the coring part of the project they also used the Proceq GP8000 ground penetrating radar (GPR) concrete scanning system to locate and mark the structural steel prior to coring.

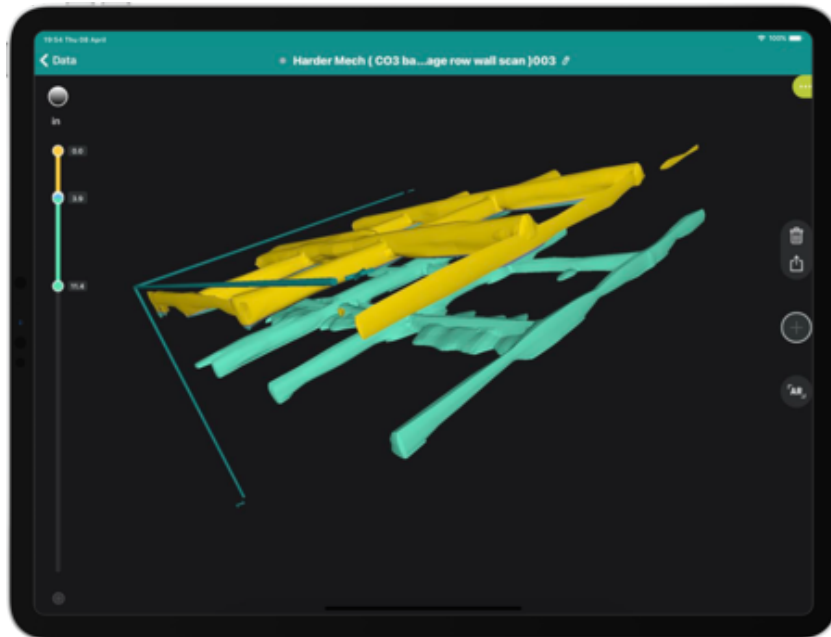
Due to the high-profile nature of the project Bedrock used a combination of line scans and area scans to confirm rebar location and document results for their client. Area scan results have the benefit of simplifying the scan findings into easy to understand top-down and volumetric views. Saved too and shared from the cloud, review of scan results can be a collaborative effort direct from the field to the office in almost real-time.
