# Identify and Characterize Defects in Forged Components like Gas Turbine Rotors

This application note describes how to inspect gas turbine rotors with ultrasonics.

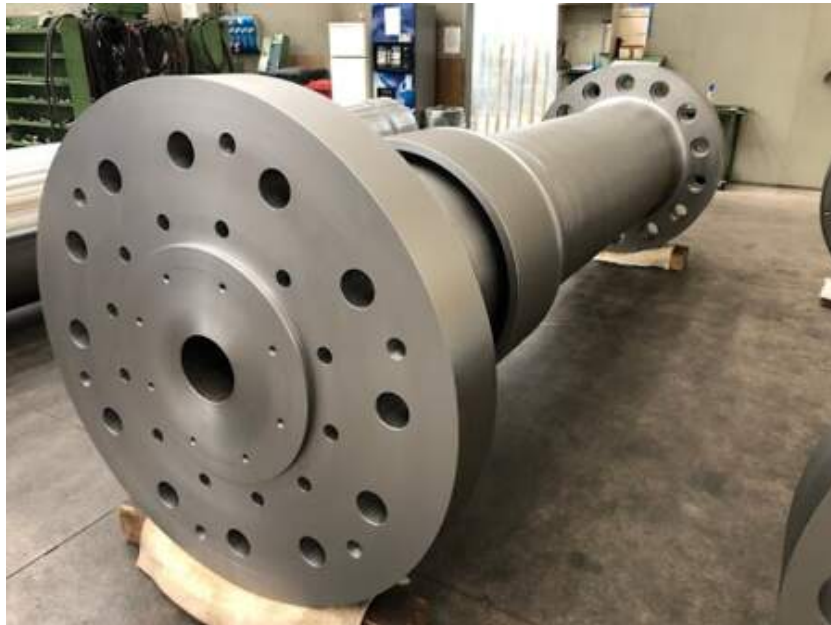
The forged disk shall be 100% ultrasonically tested according with the EN 10228-3.

- Roughness of the surfaces must not exceed 12.5  $\mu\text{m Ra}$
- Surface cleaned and free from dirt, grease, paint, etc

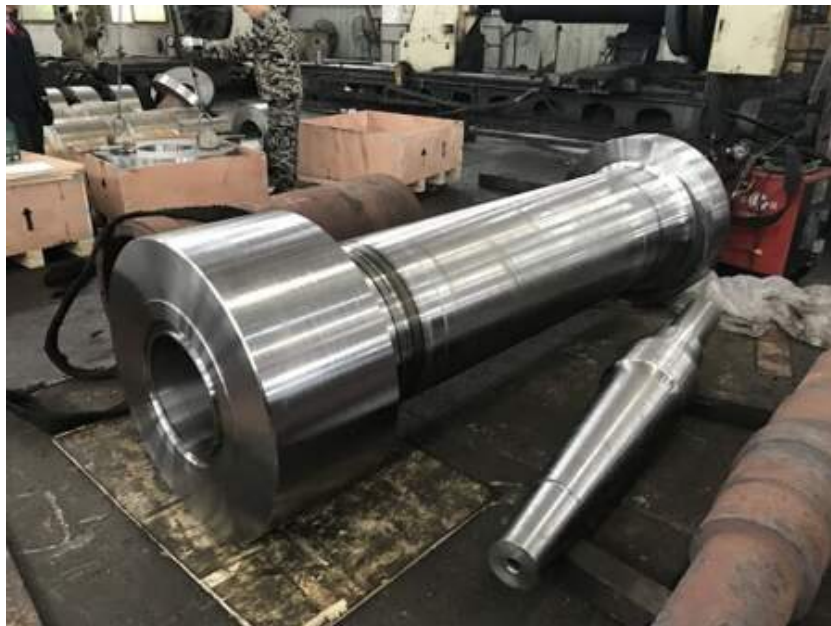
According to the table reported in the norm, the technician should be able to identify isolated discontinuities and grouped discontinuities.

The micro-structure of the material as well the thickness can have impact on the ultrasound inspection, having a good signal-to-noise rate is important to identify grouped discontinuities as well isolated discontinuities.

DGS or DAC curve can be used to identify and characterize the defects in forged components like gas turbine rotors.

With the [Proceq UT8000](#) you have the possibility to record the A Scan pick of the defects and export the images/video directly on the report. Thanks to his 400 V square pulse you have the possibility to work with a lower noise level that allow the technician to identify and classify, more easily, the extended or grouped discontinuities defect. With his great signal- to- noise rate, UT8000 is making it easier to identify the defect.
