Efficiently Monitoring the Performance of Road Markings and Signs

Overview

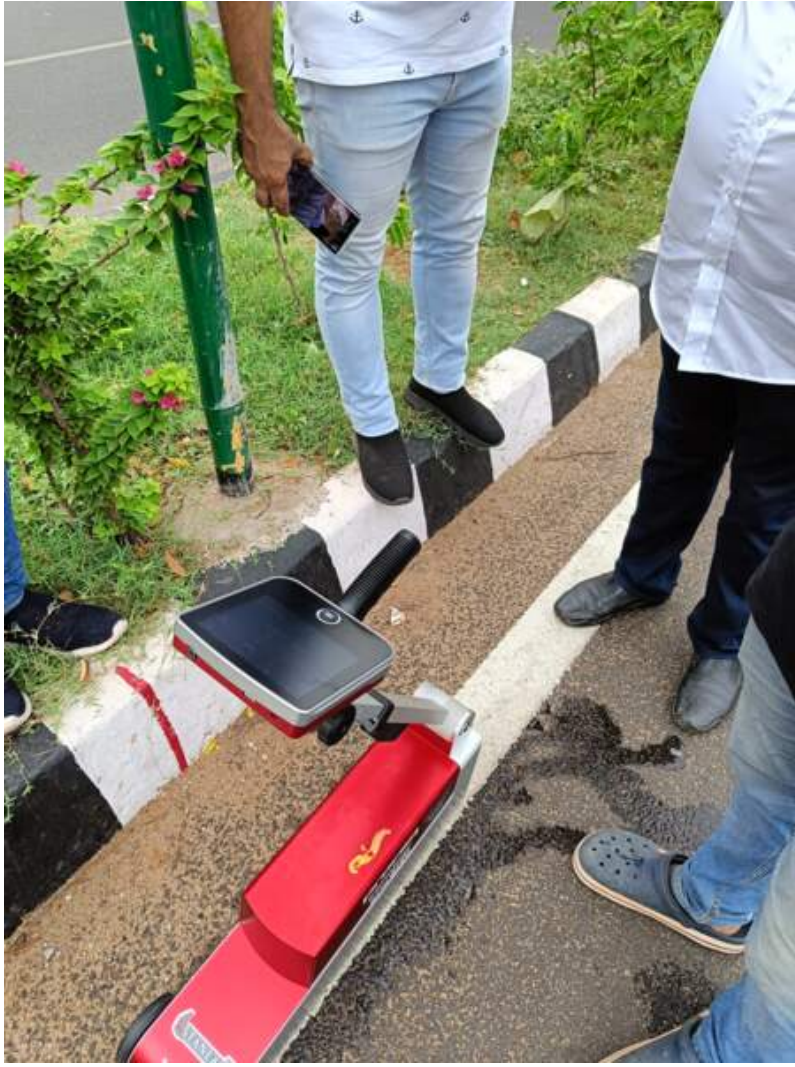
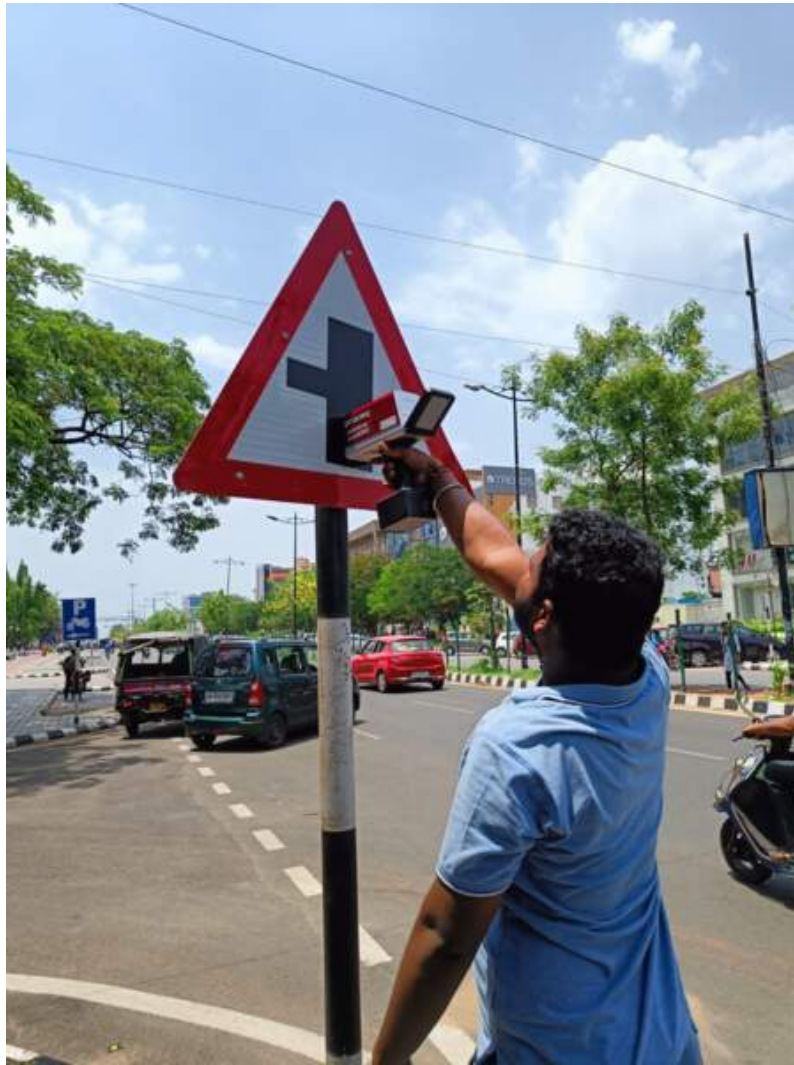
1. The advanced ZRM6014RL Retroreflectometer was used for pavement markings with GPS.
2. Zehntner ZRS6060 Retroreflectometer was used for road signages with GPS.

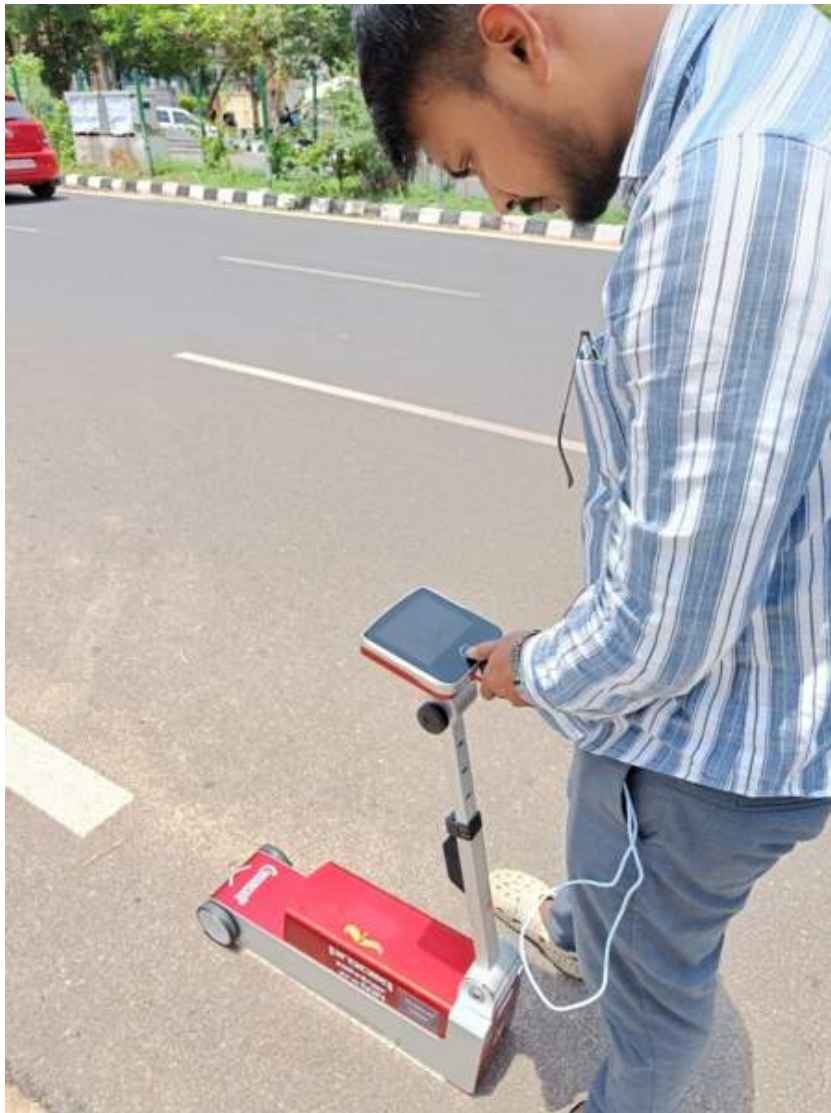
Measuring example ZRM 6014 with optional camera

Enabled with 5.7" high-resolution color touchscreen, the retroreflectometer offers excellent visibility under all light conditions. The retroreflectometer logs all measurements with precise geolocation & provides comprehensive reports quickly with the help of user-friendly reporting software at ease.

Clever "MappingTools" software for easy data display and analysis
